Brookview Community Center Building Assessment

July 1, 2014

HGA COMMISSION NUMBER 2065-004-00

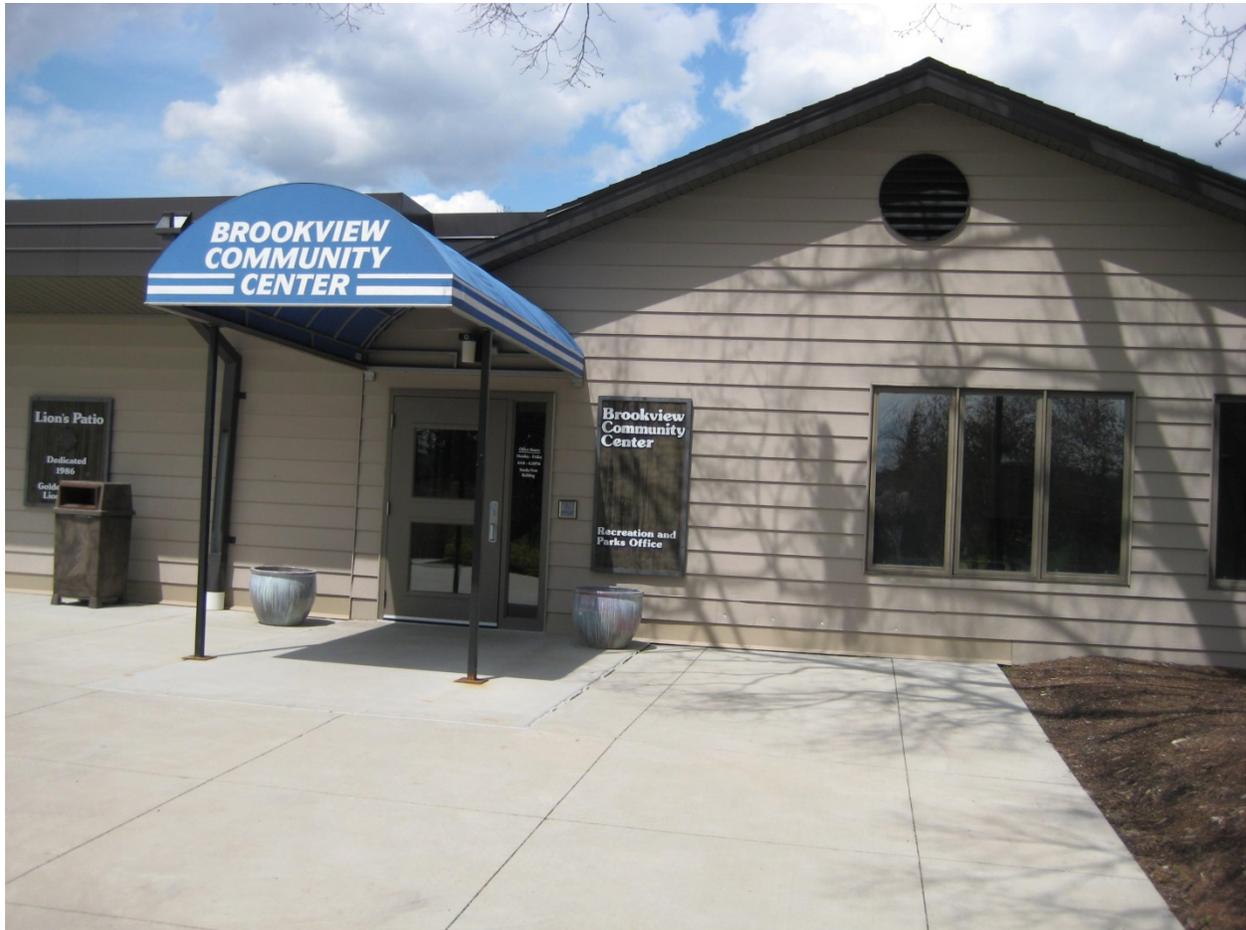
Main Entrance to Community Center

- First Level elevated from parking below by one story.
- Anyone disable forced to traverse ramping system to enter this level.
- Seniors forced to climb stairs to enter rather than at-grade.

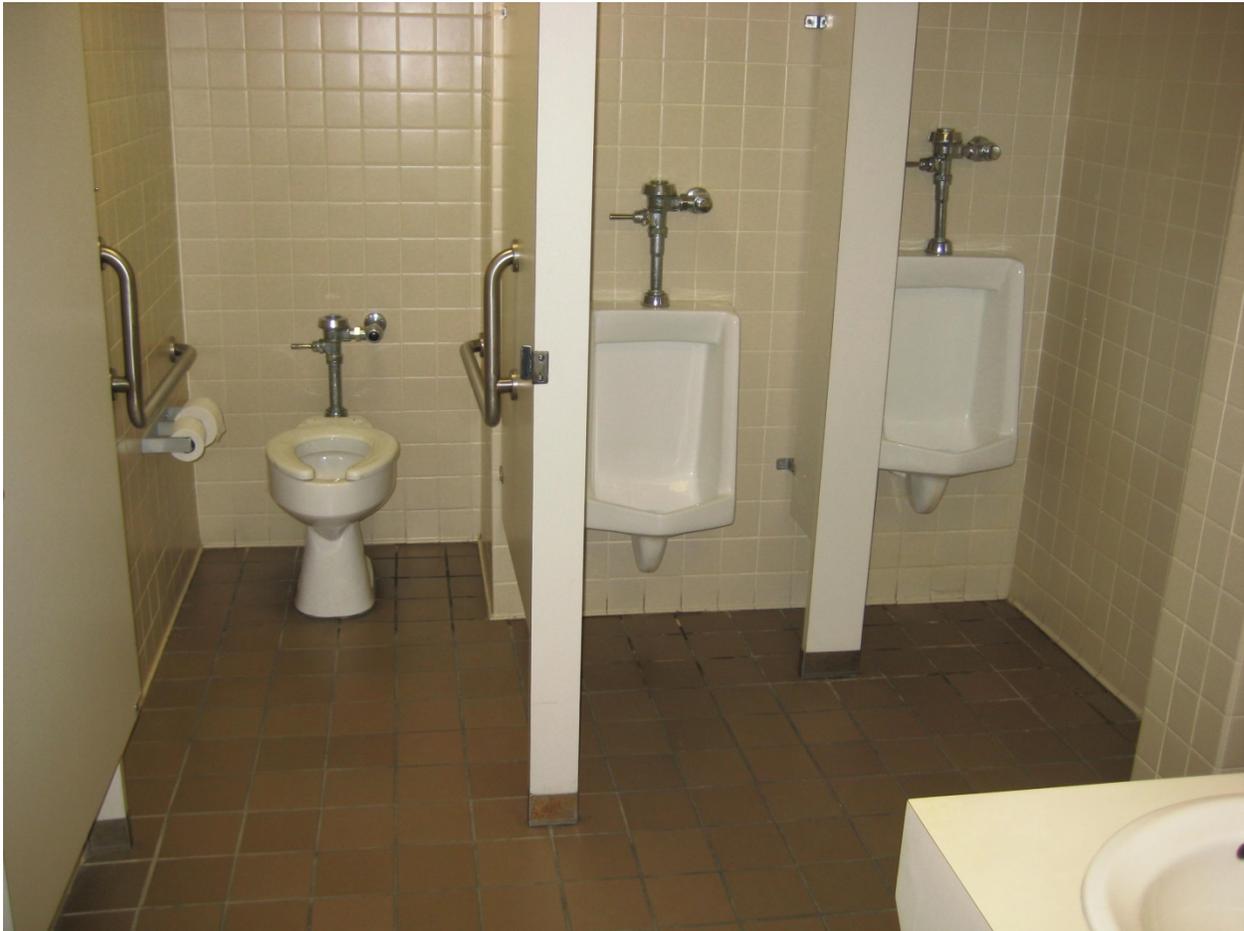
Restroom Stall

Does not meet MN State Accessibility Code requirements

- Inadequate clearances within stall, typical for each
- Grab bars not to code

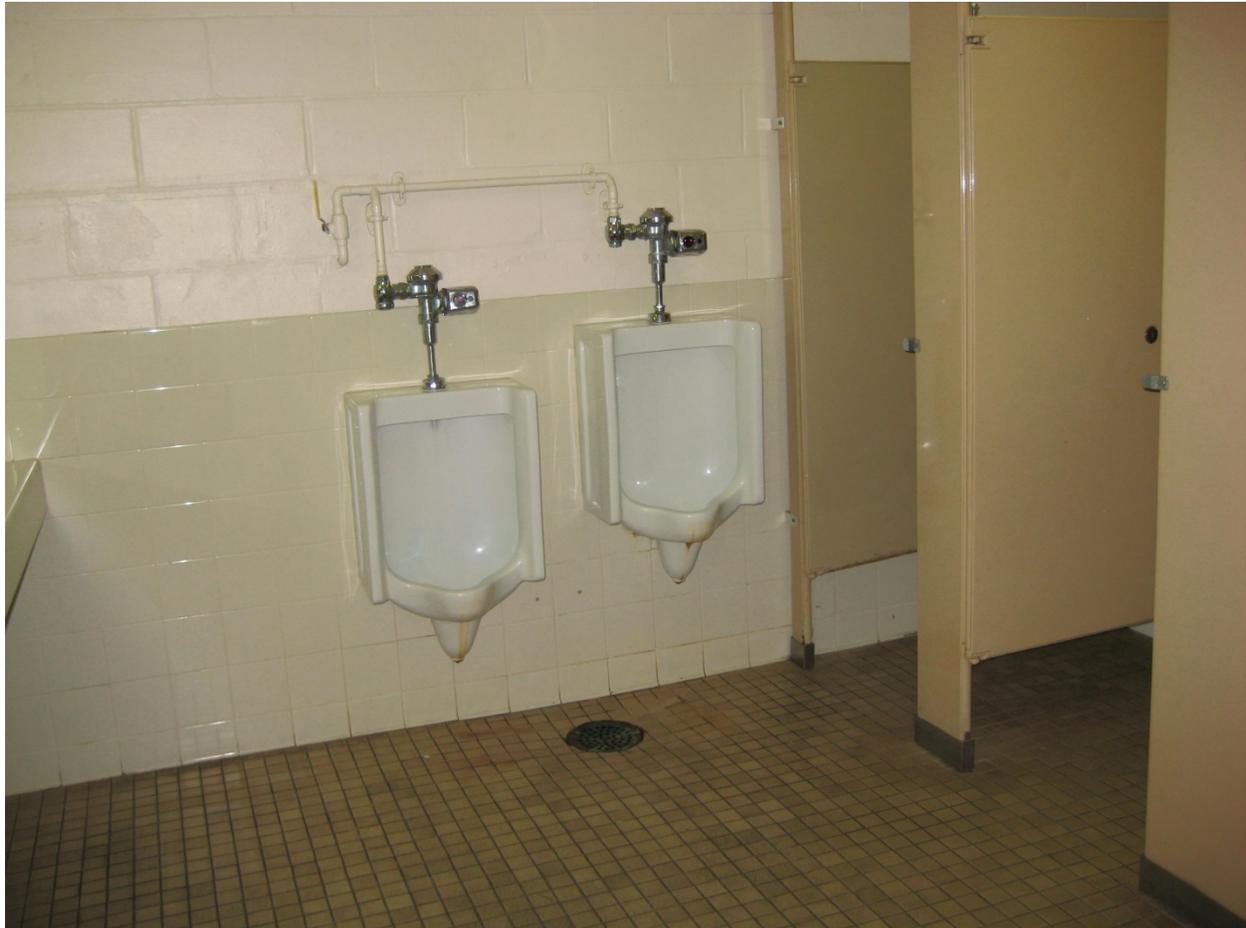
Restroom Urinals

Does not meet MN State Accessibility Code requirements.

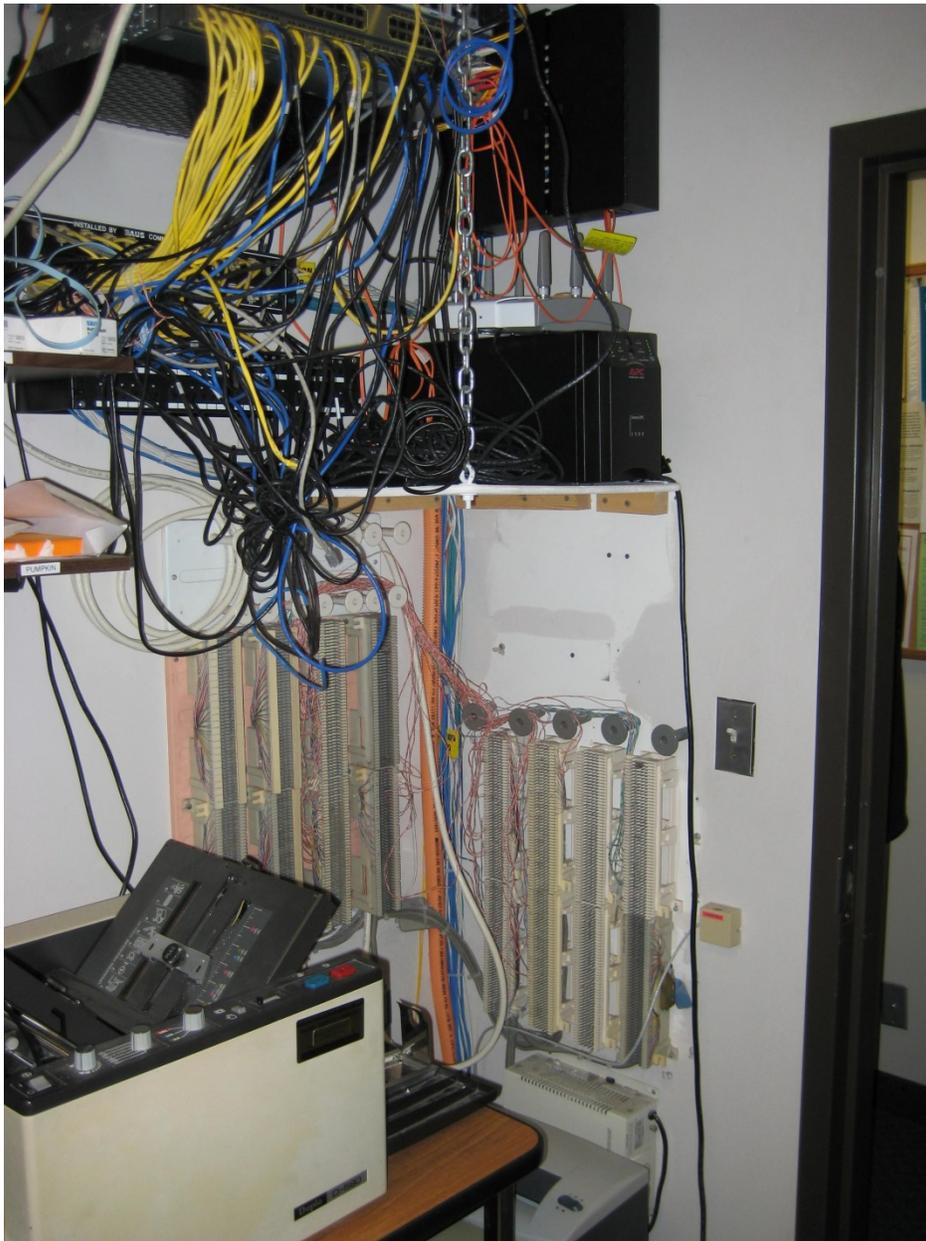
IT Room, Office Storage, Copy Room

- Inadequate space
- Hazardous

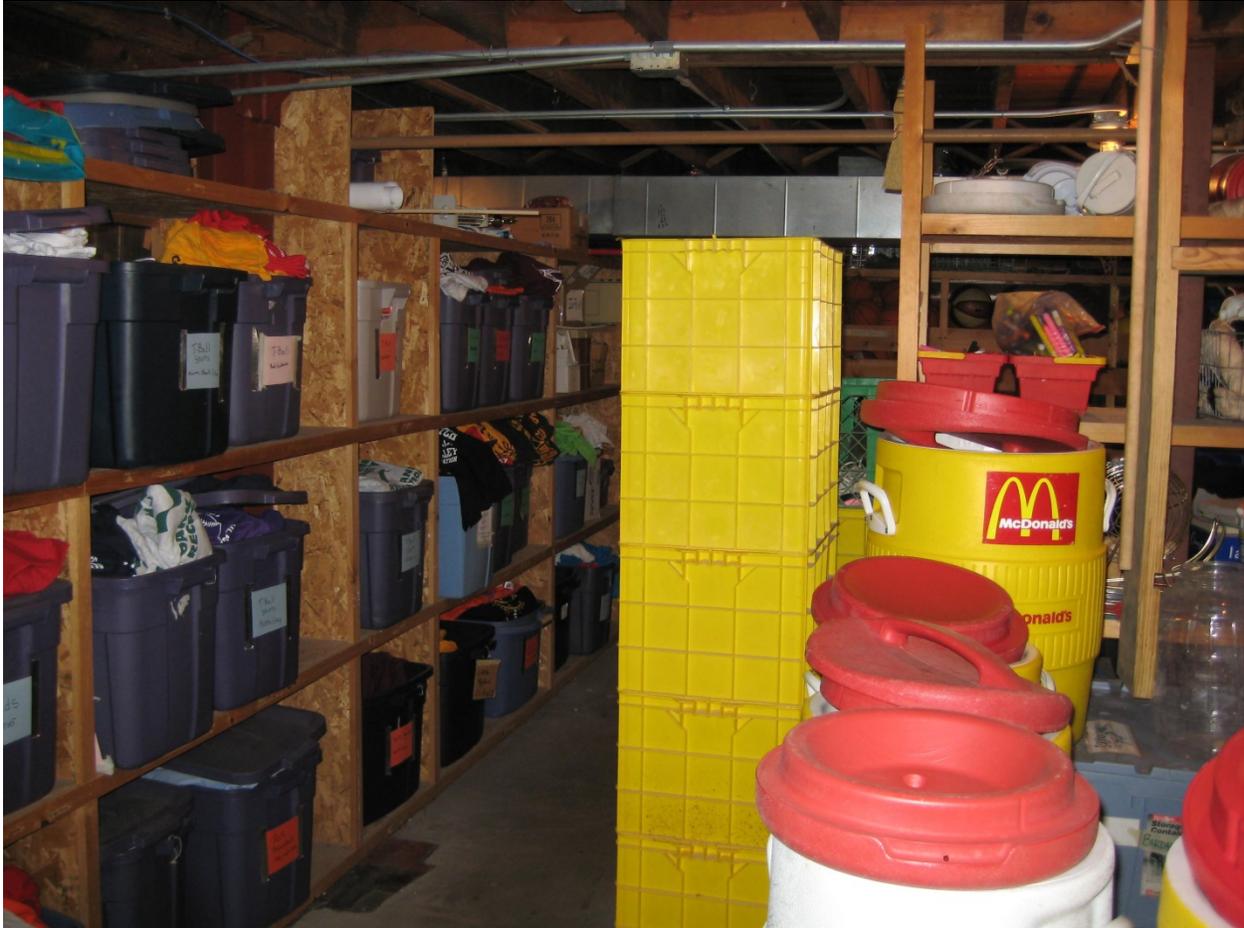
It was observed that the original 1918 portion of the Center has settled and is not level (refer to the structural report for more information). Much of the main storage for the facility is within the mechanical room in the Lower Level, which is not permitted and would need correction.

- Building storage within Mechanical Room
- No sprinkler system in storage room

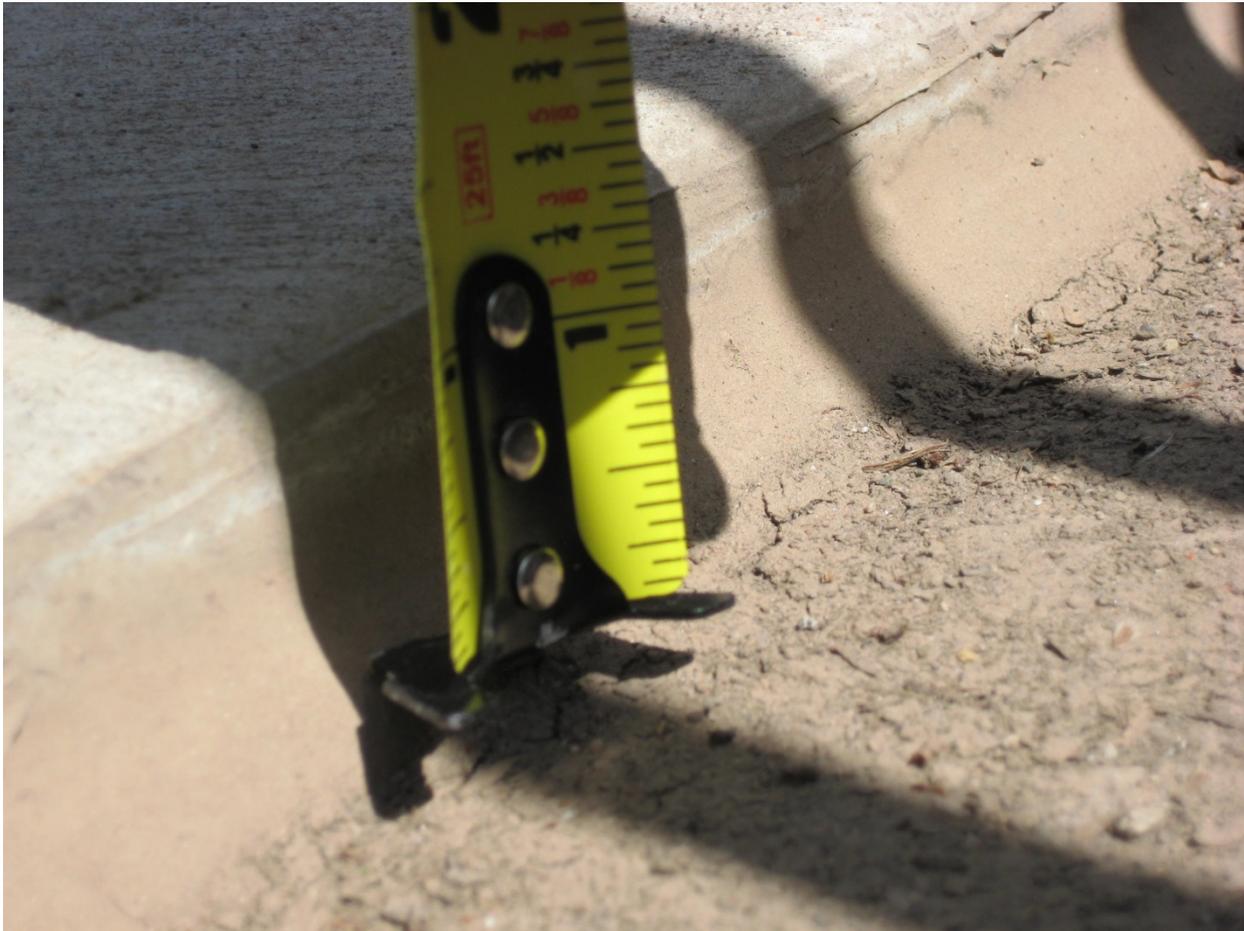
Ramp

It was observed that the site retaining wall adjacent to the golf clubhouse area is settling and pulling away. Due to this, it is also pulling away portions of the patio, walkway and ramp. This uneven settlement has created uneven pavement, causing a tripping hazard. At the base of the ramp leading from this area to the First Level, the settlement differential is in excess of 1", which is greater than that allowed by code for an accessible ramp.

Base of ramp leading to the First Level

- Does not meet MN State Accessibility Code requirements
- Greater than 1/2" permitted by code

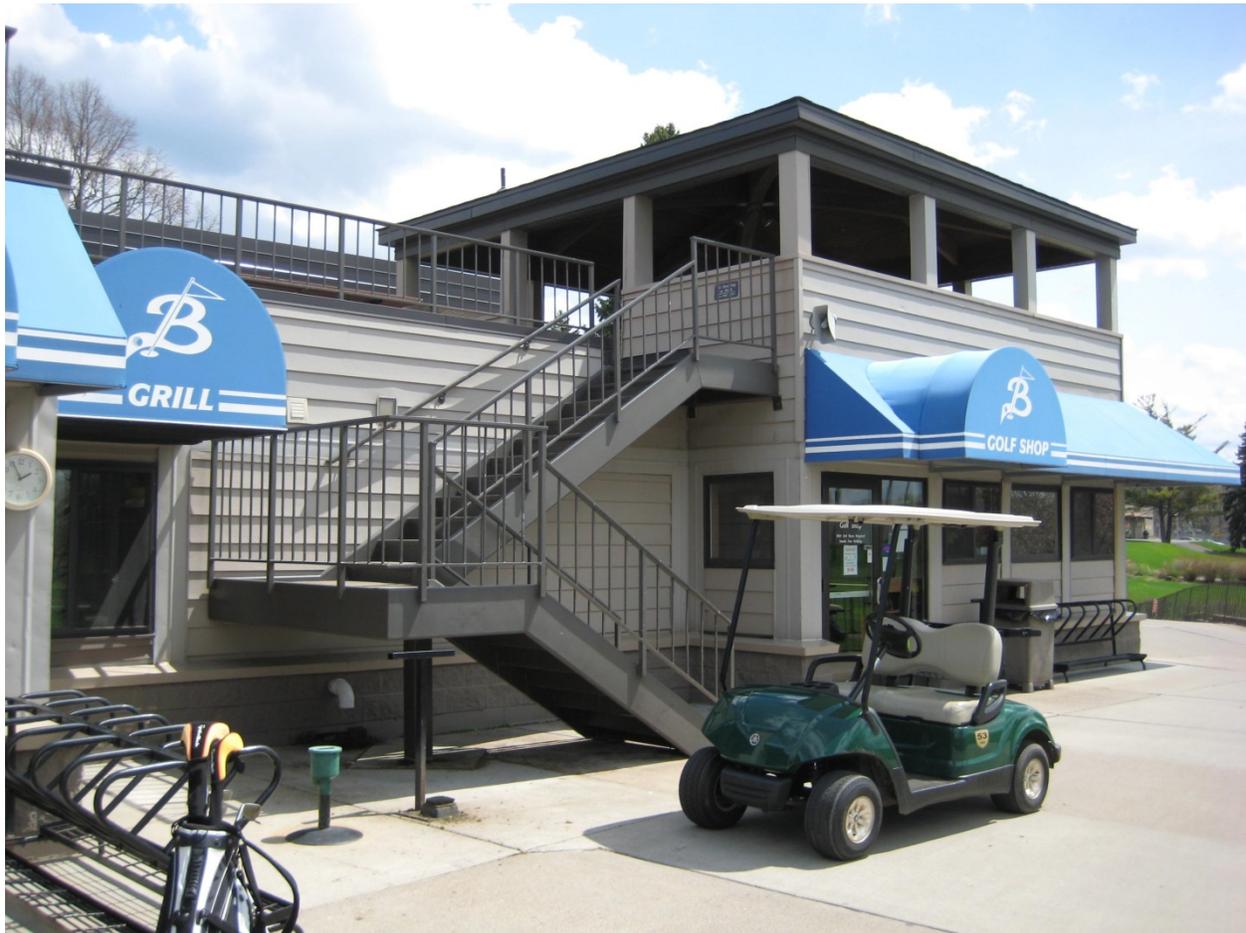
Guardrails

Checking the existing required egress components, it is observed that none of the existing stairs meet current code, mostly due to handrail and guardrail requirements. Given that this is a public facility, the exit stairs would need to be updated per current MSBC requirements as part of any renovation.

Does not meet MSBC Chapter 10 requirements for guardrail at open side of stair an on Upper Level

- Dimension between pickets cannot exceed 4"

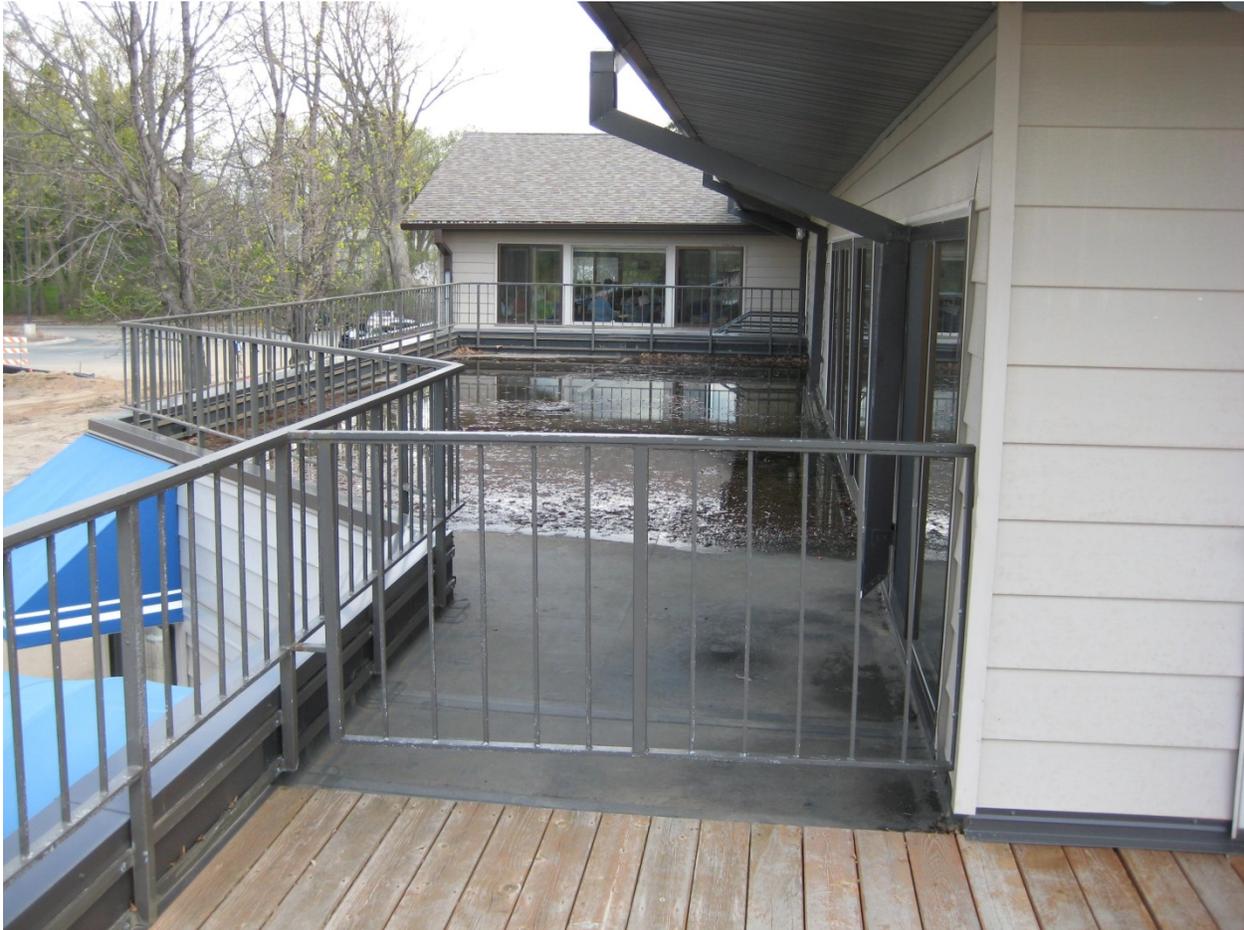
Roof

The flat roof areas are not adequately sloped to the roof scuppers, resulting in ponding water. Not surprisingly, water damage to the rooms below this area, as well as to the foundation walls, can be observed. The existing windows are not thermally efficient and have some rot due to exposure to the elements and leaking over the years.

- Ponding water due to inadequate slope to roof scuppers at perimeter wall.
- Water damage observed to areas below.

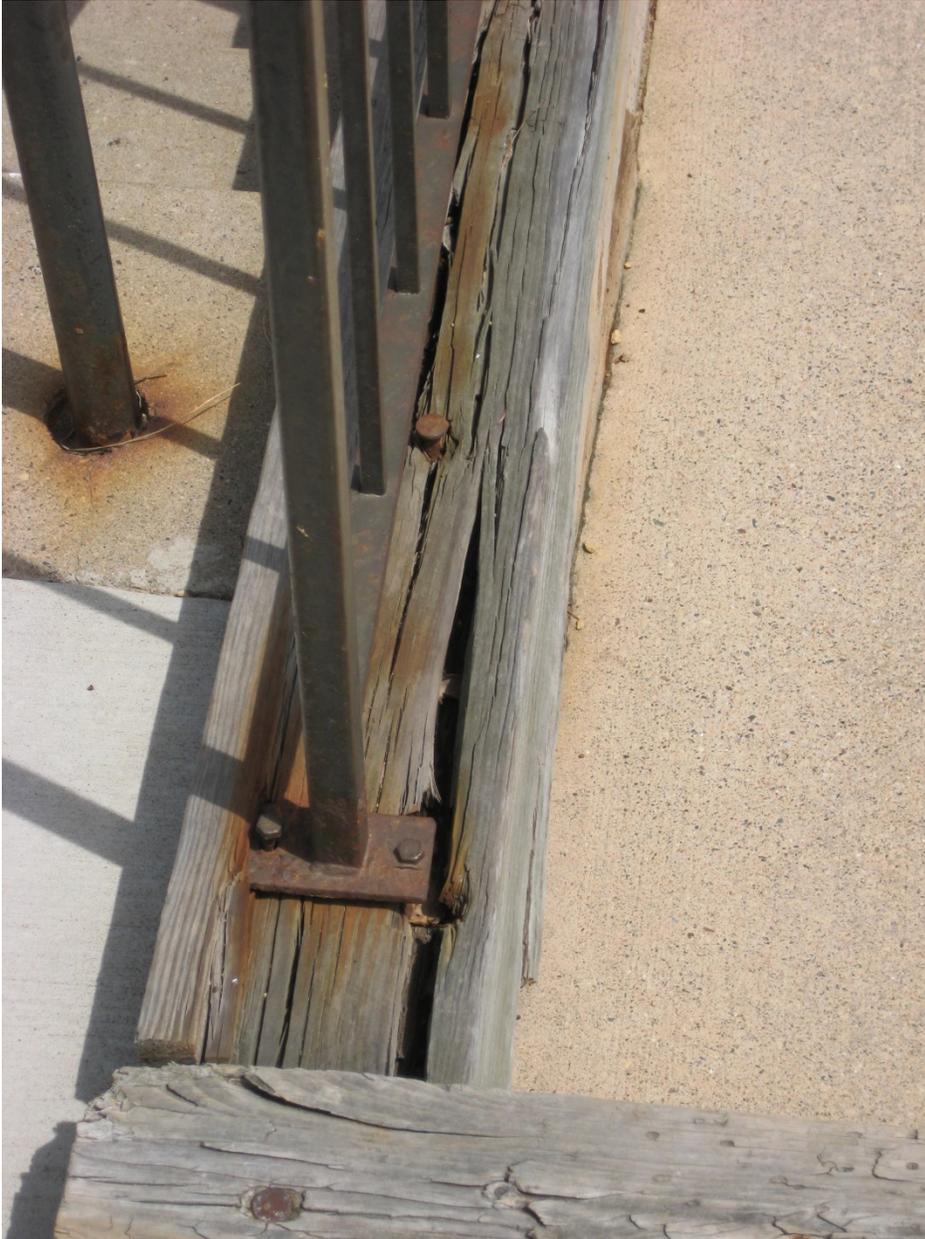
- Rot at required guardrail.
- Guardrail a hazard; can move 6" either direction.
