# BUILDING ASSESSMENT

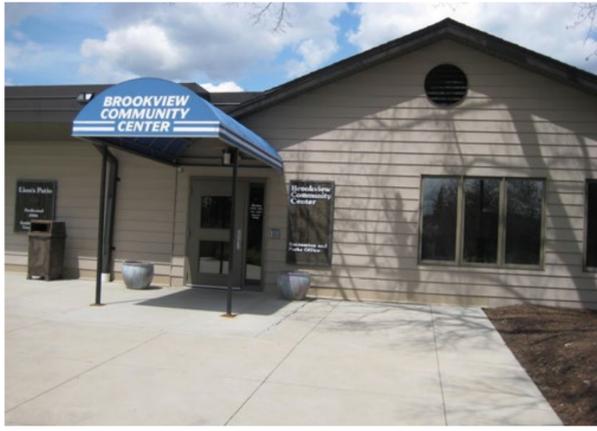
First level elevated from parking below by one story

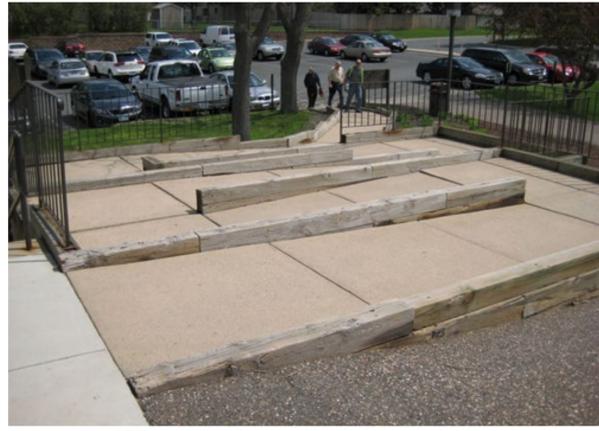
Disabled patrons forced to traverse ramping system to access first level

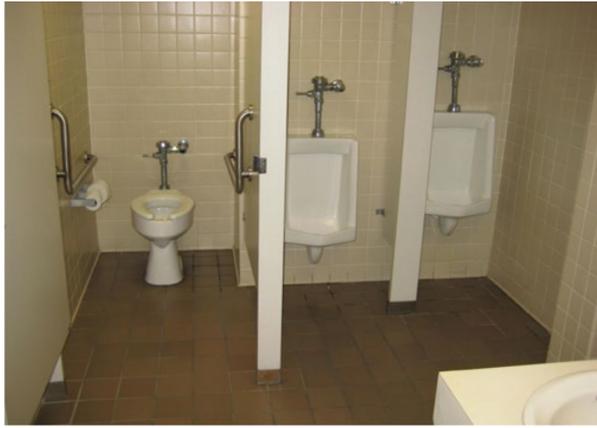
Restroom stalls do not meet MN State Accessibility Code requirements

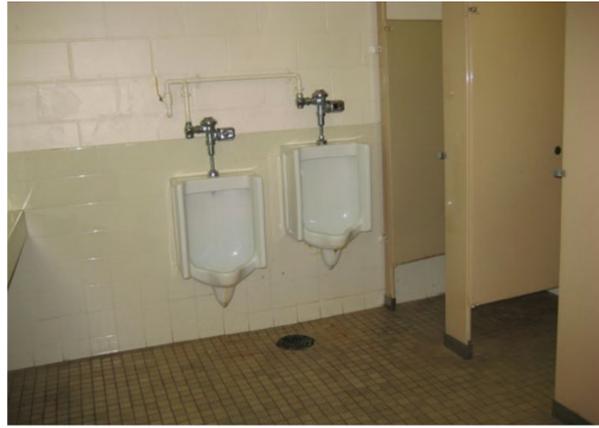
Restroom stalls do not meet MN State Accessibility Code requirements

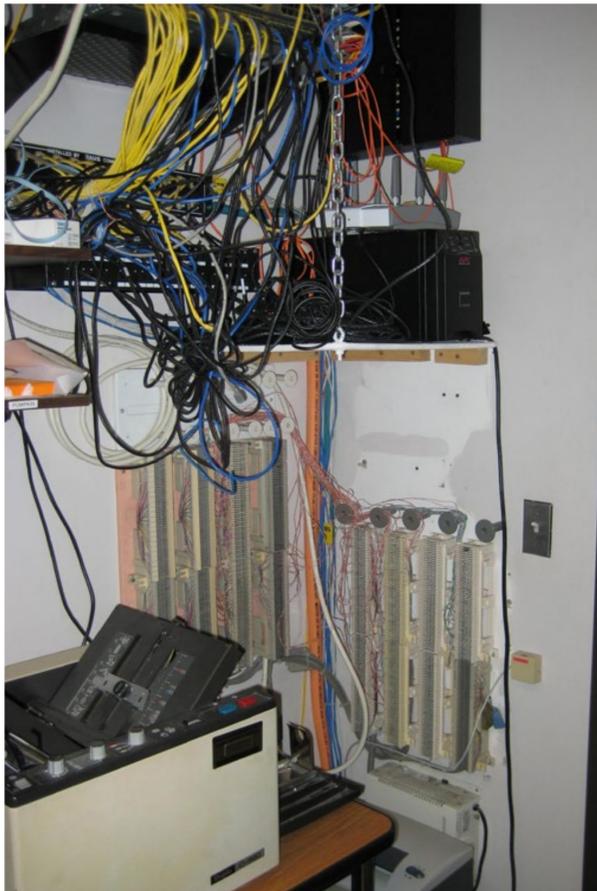
IT Room/Office Storage/Copy Room inadequate space and hazardous

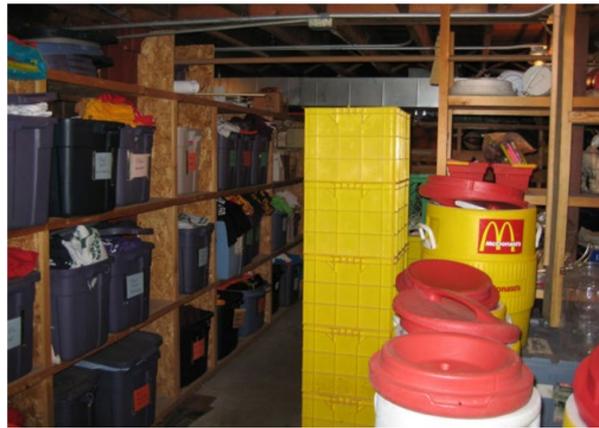
Building storage within Mechanical Room. No sprinkler system in storage room

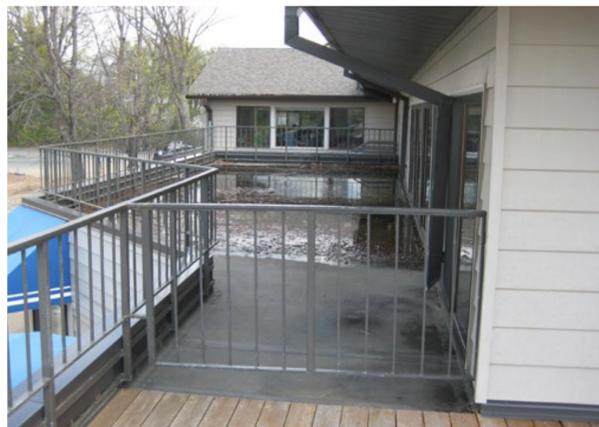
Ponding water due to inadequate slope to roof scuppers at perimeter wall resulting in water damage to areas below

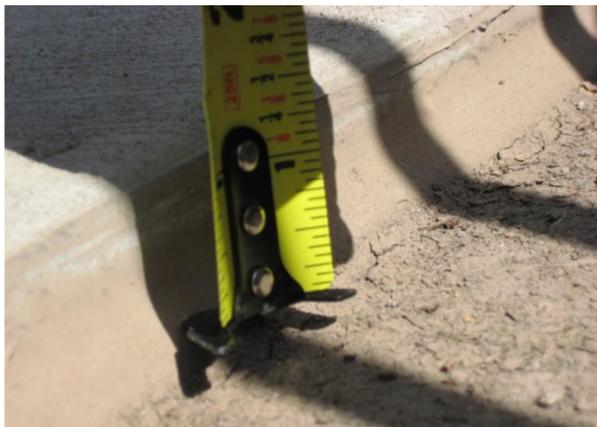
Base of ramp leading to the First Level does not meet MN State Accessibility Code requirements

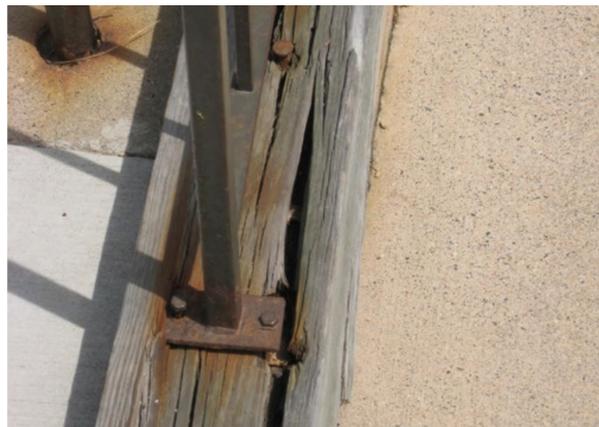
Rot at required guardrail resulting in hazardous guardrail condition
