Briarwood Nature Area

Location: 2500 Unity Avenue North

Briarwood Nature Area - 2012 Aerial
 Golden Valley Natural Resources Management Plan

FIGURE 5.12

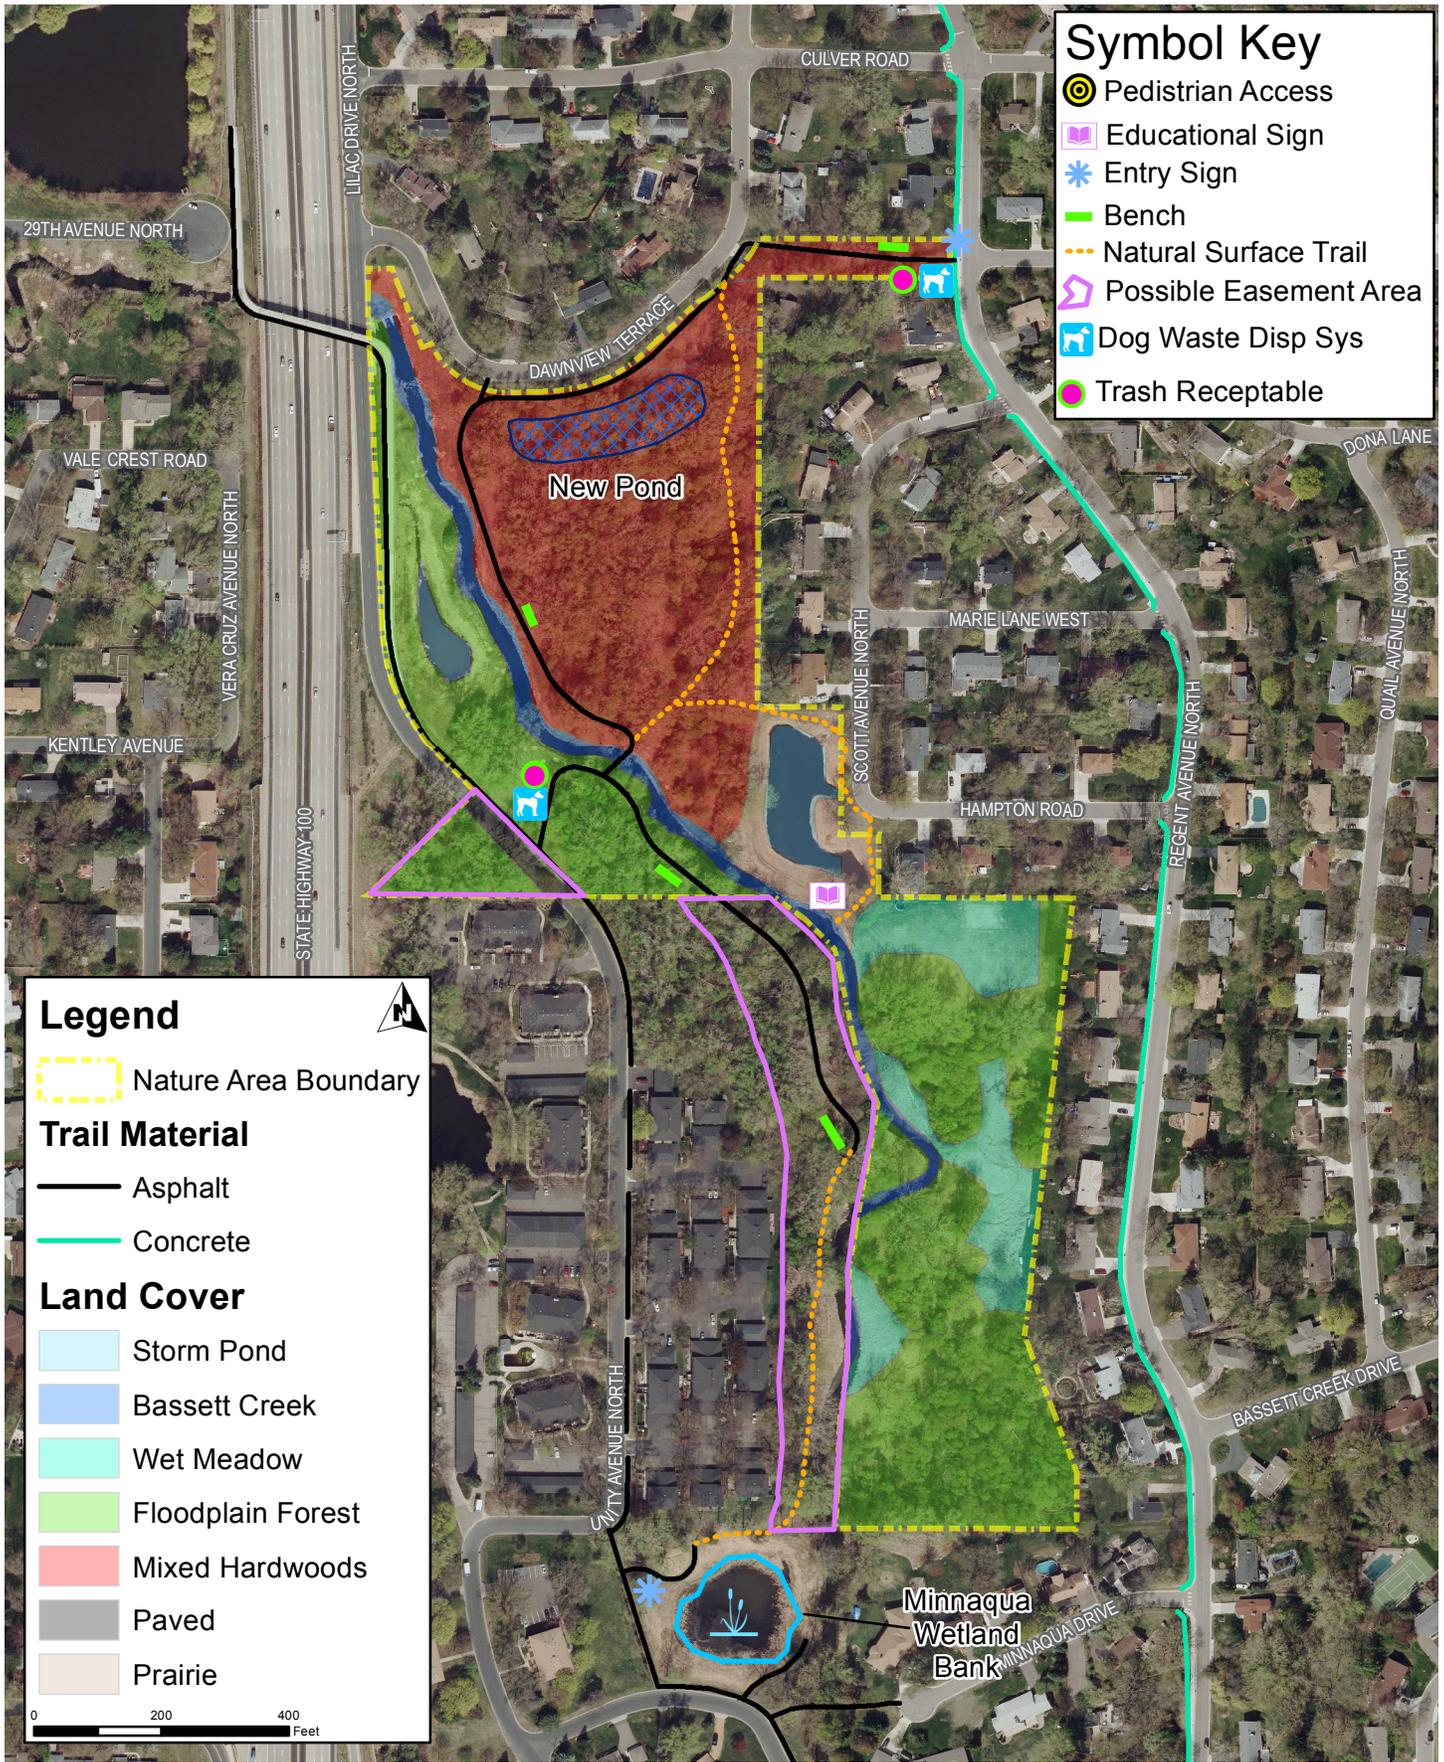
Legend

- Nature Area Boundary
- Trail Material**
- Asphalt
- Concrete
- Land Cover**
- Storm Pond
- Bassett Creek
- Wet Meadow
- Floodplain Forest
- Mixed Hardwoods
- Paved
- Prairie

Symbol Key

- Pedestrian Access
- Educational Sign
- Entry Sign
- Bench
- Natural Surface Trail
- Possible Easement Area
- Dog Waste Disp Sys
- Trash Receptable
