# About the Bassett Creek Watershed Management Commission (BCWMC)

# Bassett Creek Main Stem Erosion Issues and Restoration Prioritization

# 90% Design for Reach 1, Regent Avenue to Noble Avenue

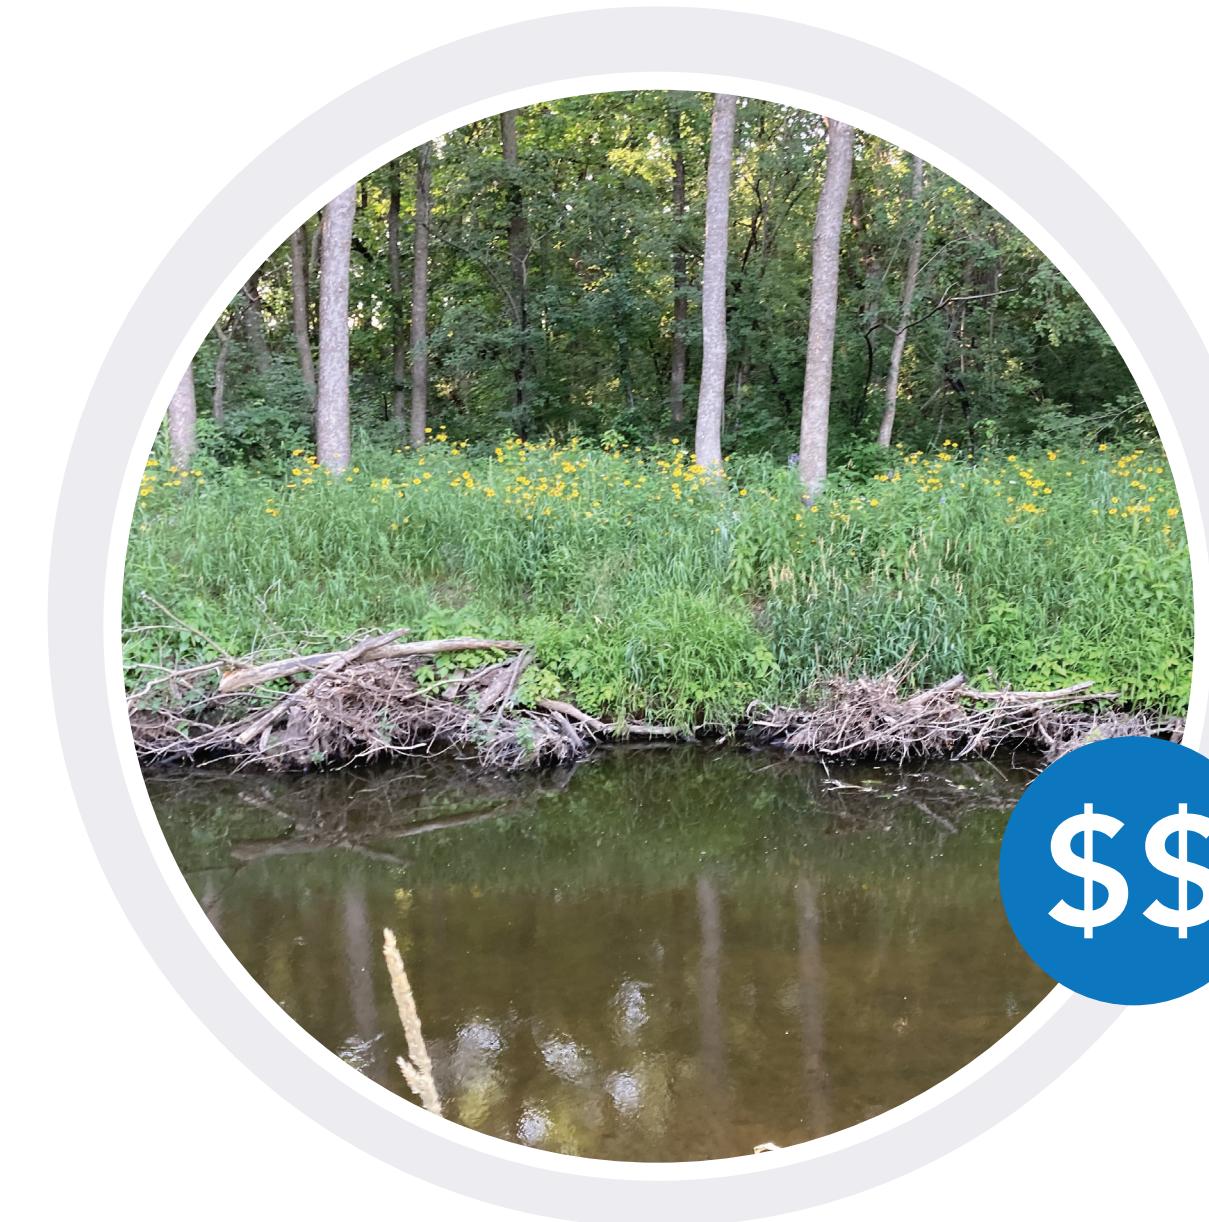
2

## Bank stabilization with bioengineering methods

Examples include: toe wood, coir logs, fascines, vegetated reinforced soil stabilization (VRSS), and live stakes

- More erosion protection along the bank itself and base of the bank, known as the bank toe
- Bioengineering and vegetation features can improve in-stream and bank habitat

- Requires establishment period for vegetation features
- Moderate grading can increase construction costs, bank disturbance, and potential tree removal

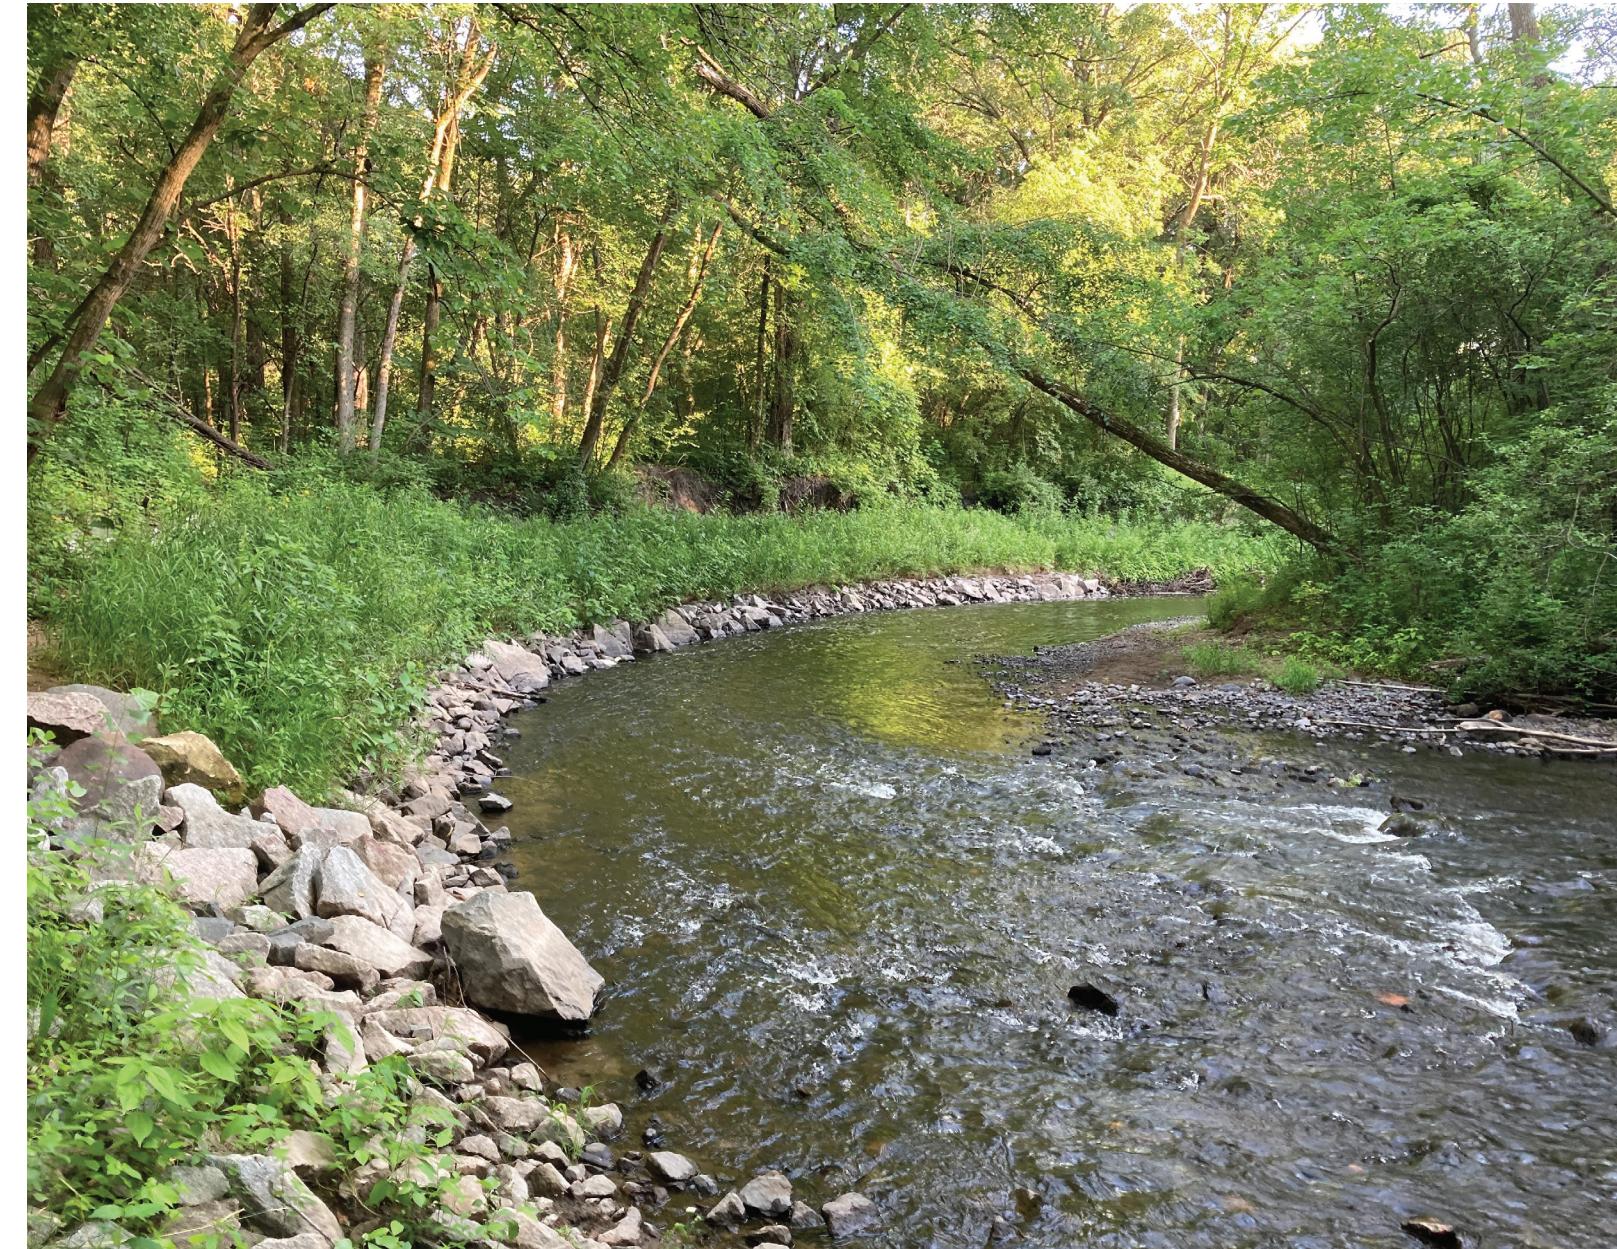
**Vegetated Reinforced Soil Stabilization (VRSS) with Riprap Toe**

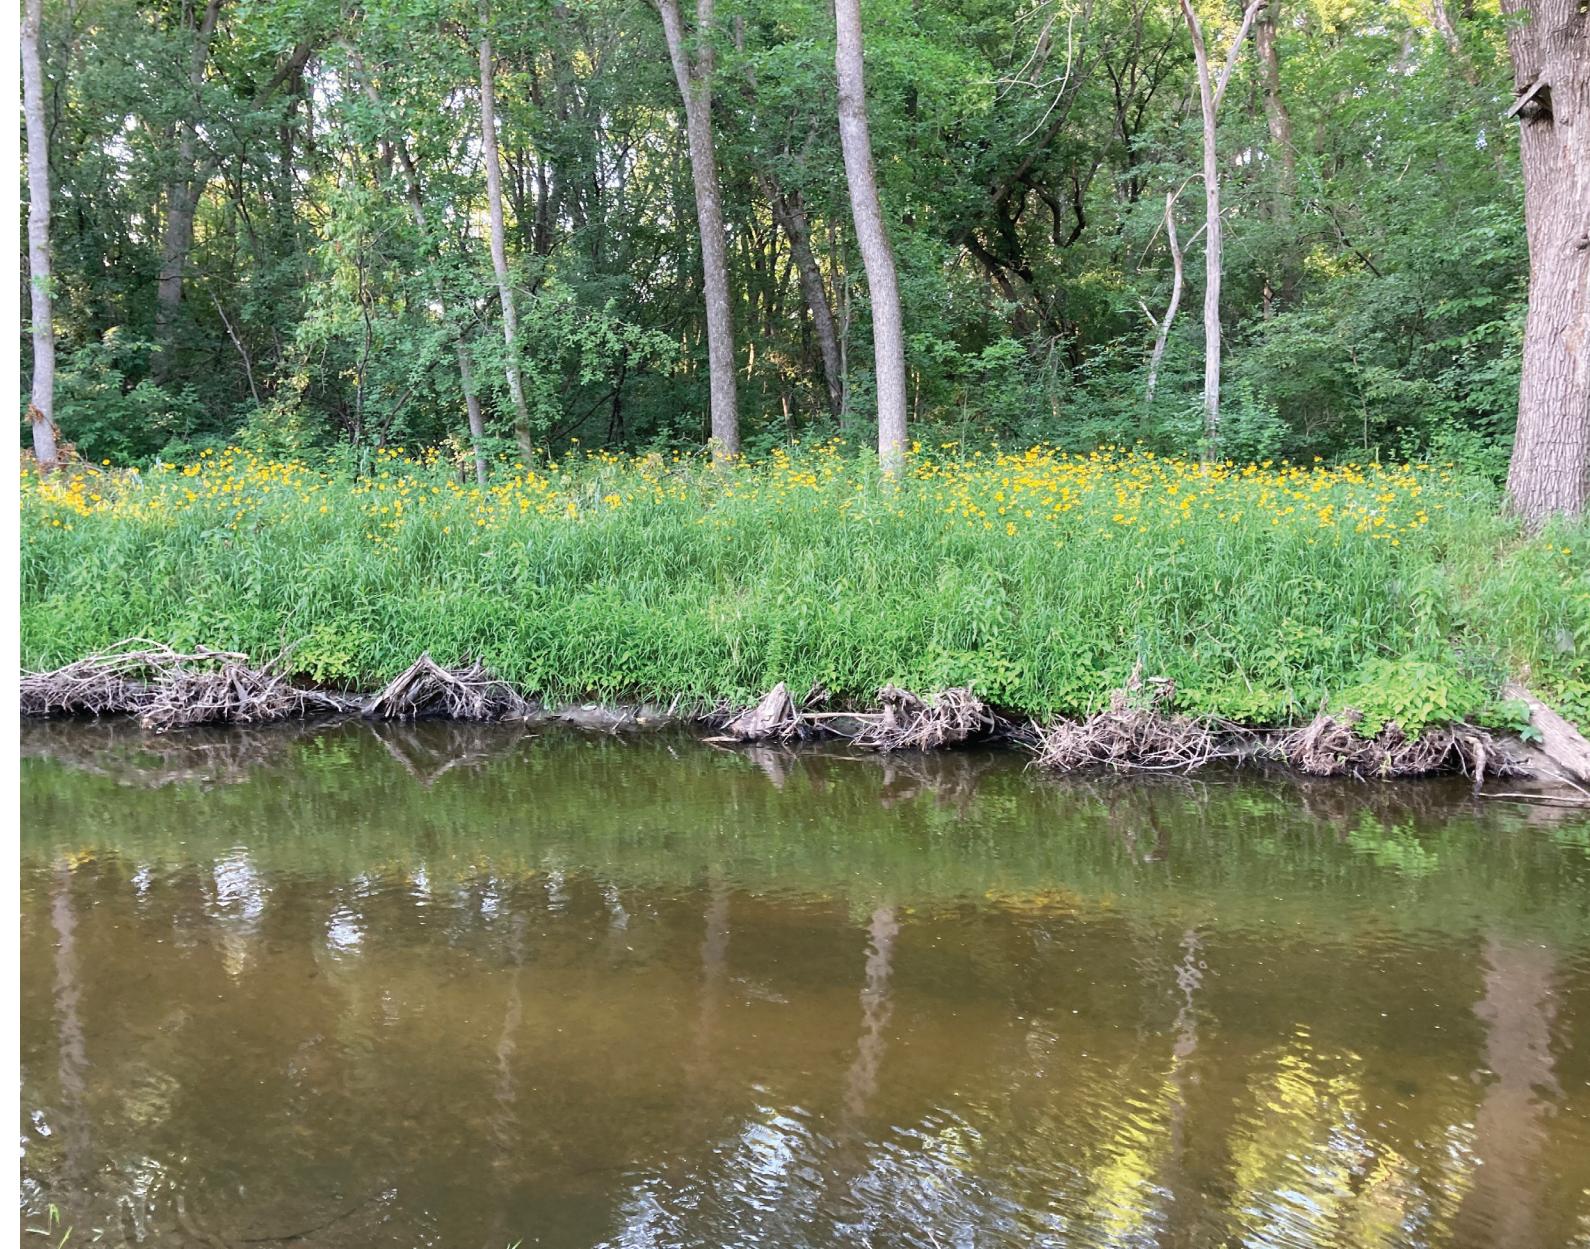
**Toe Wood with VRSS and Grading**

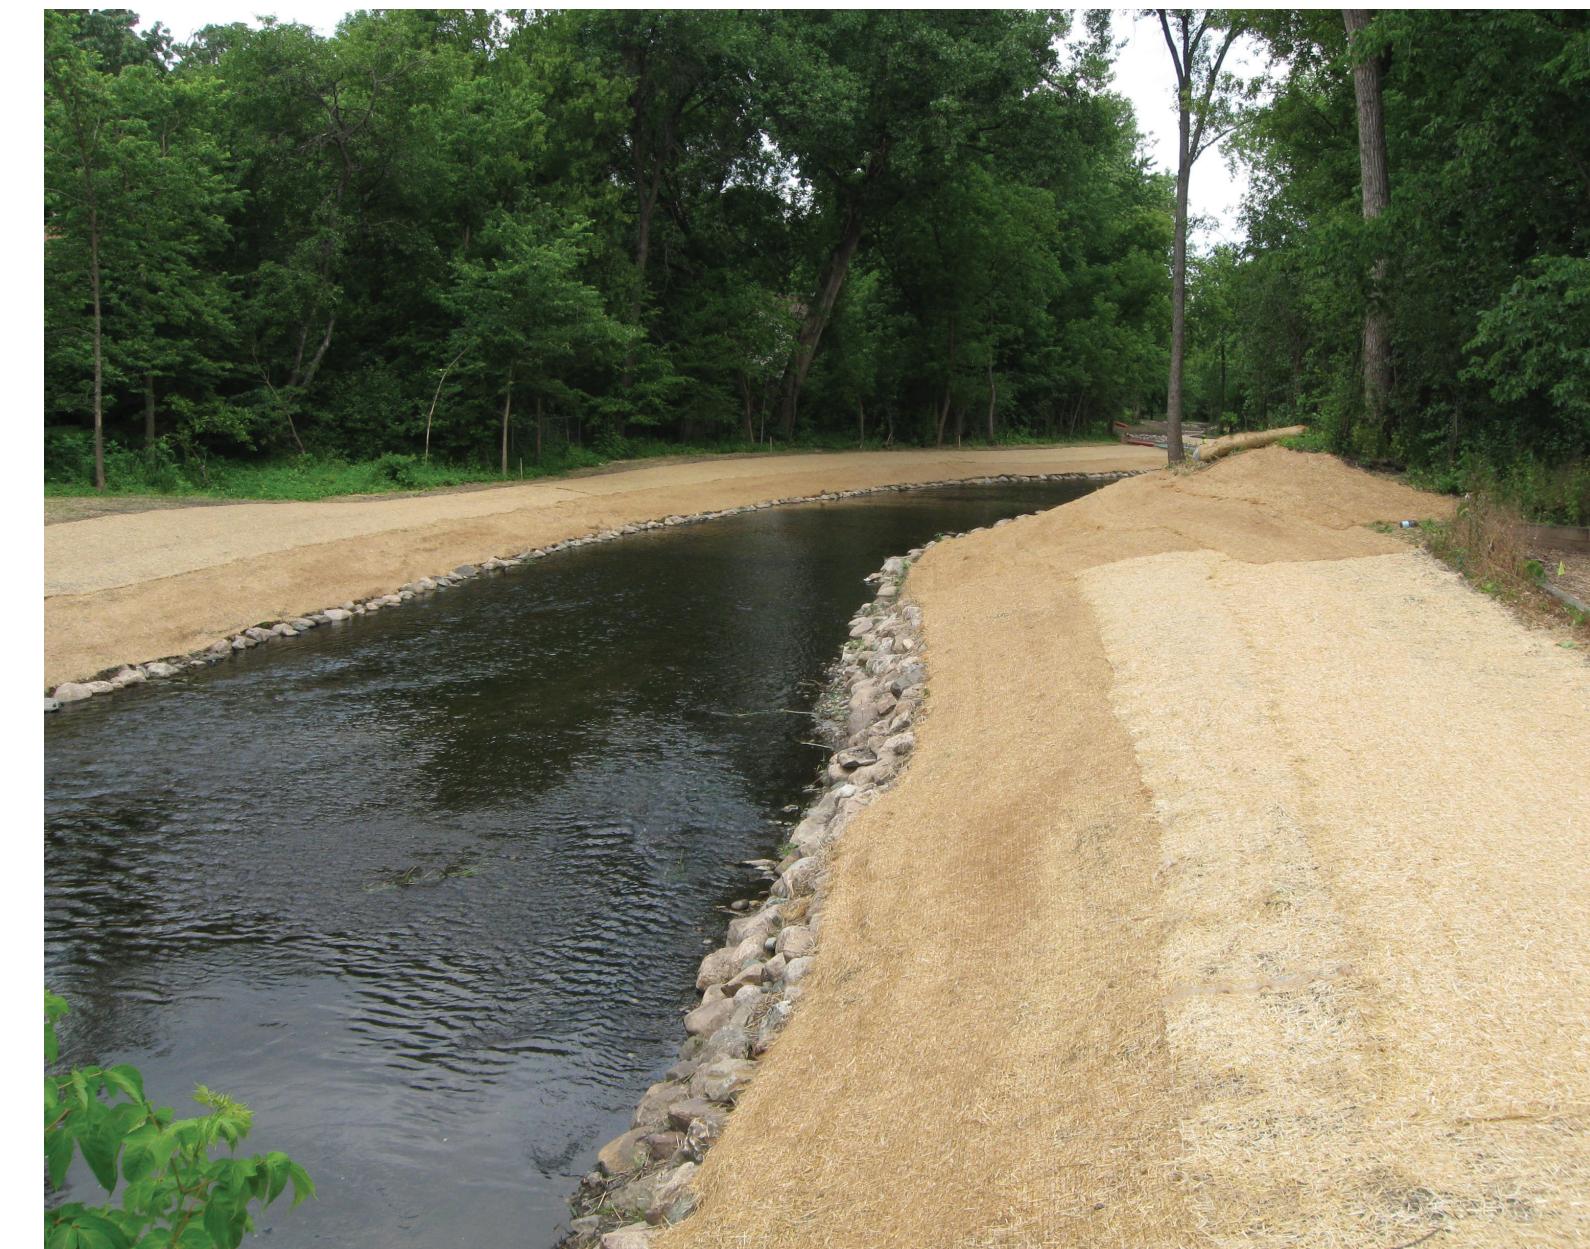
**Riprap Toe with Grading to Improve Floodplain Connection - Post construction**

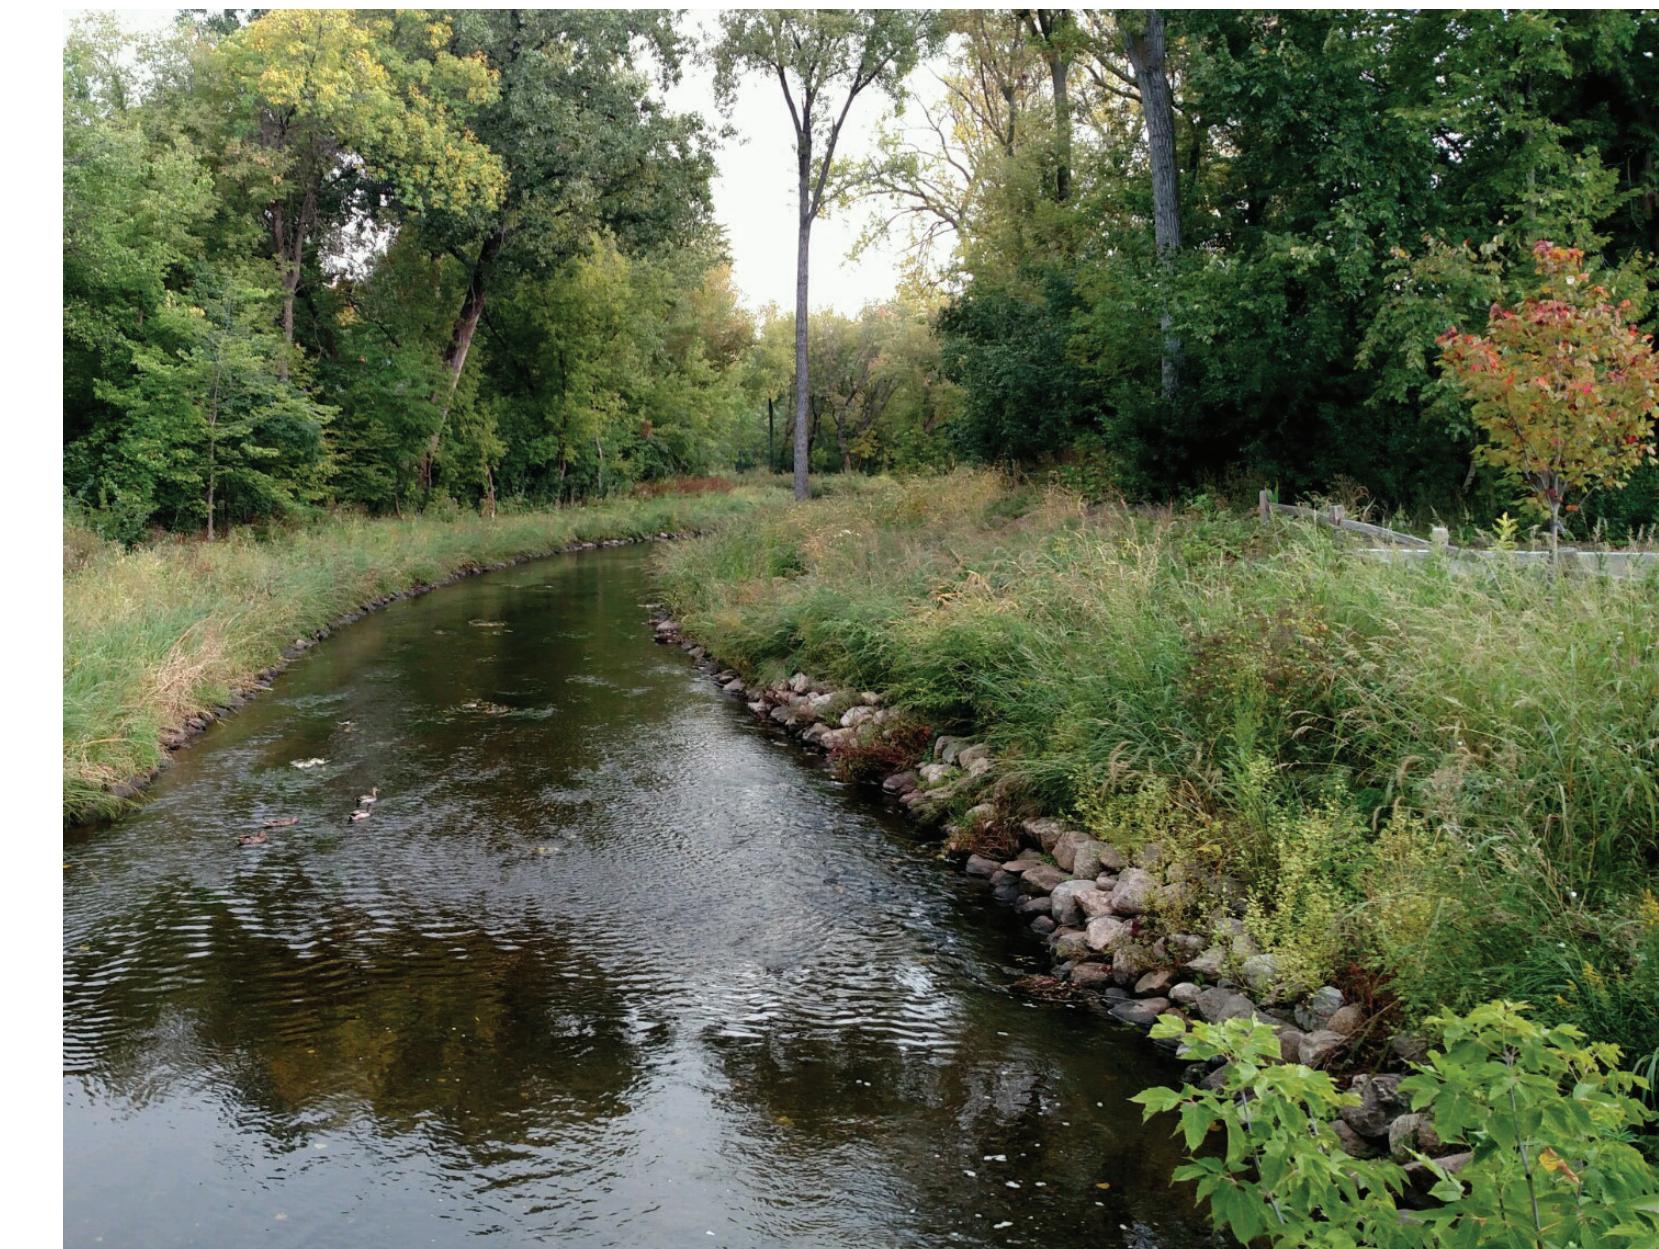
**Riprap Toe with Grading to Improve Floodplain Connection - Two years after construction**

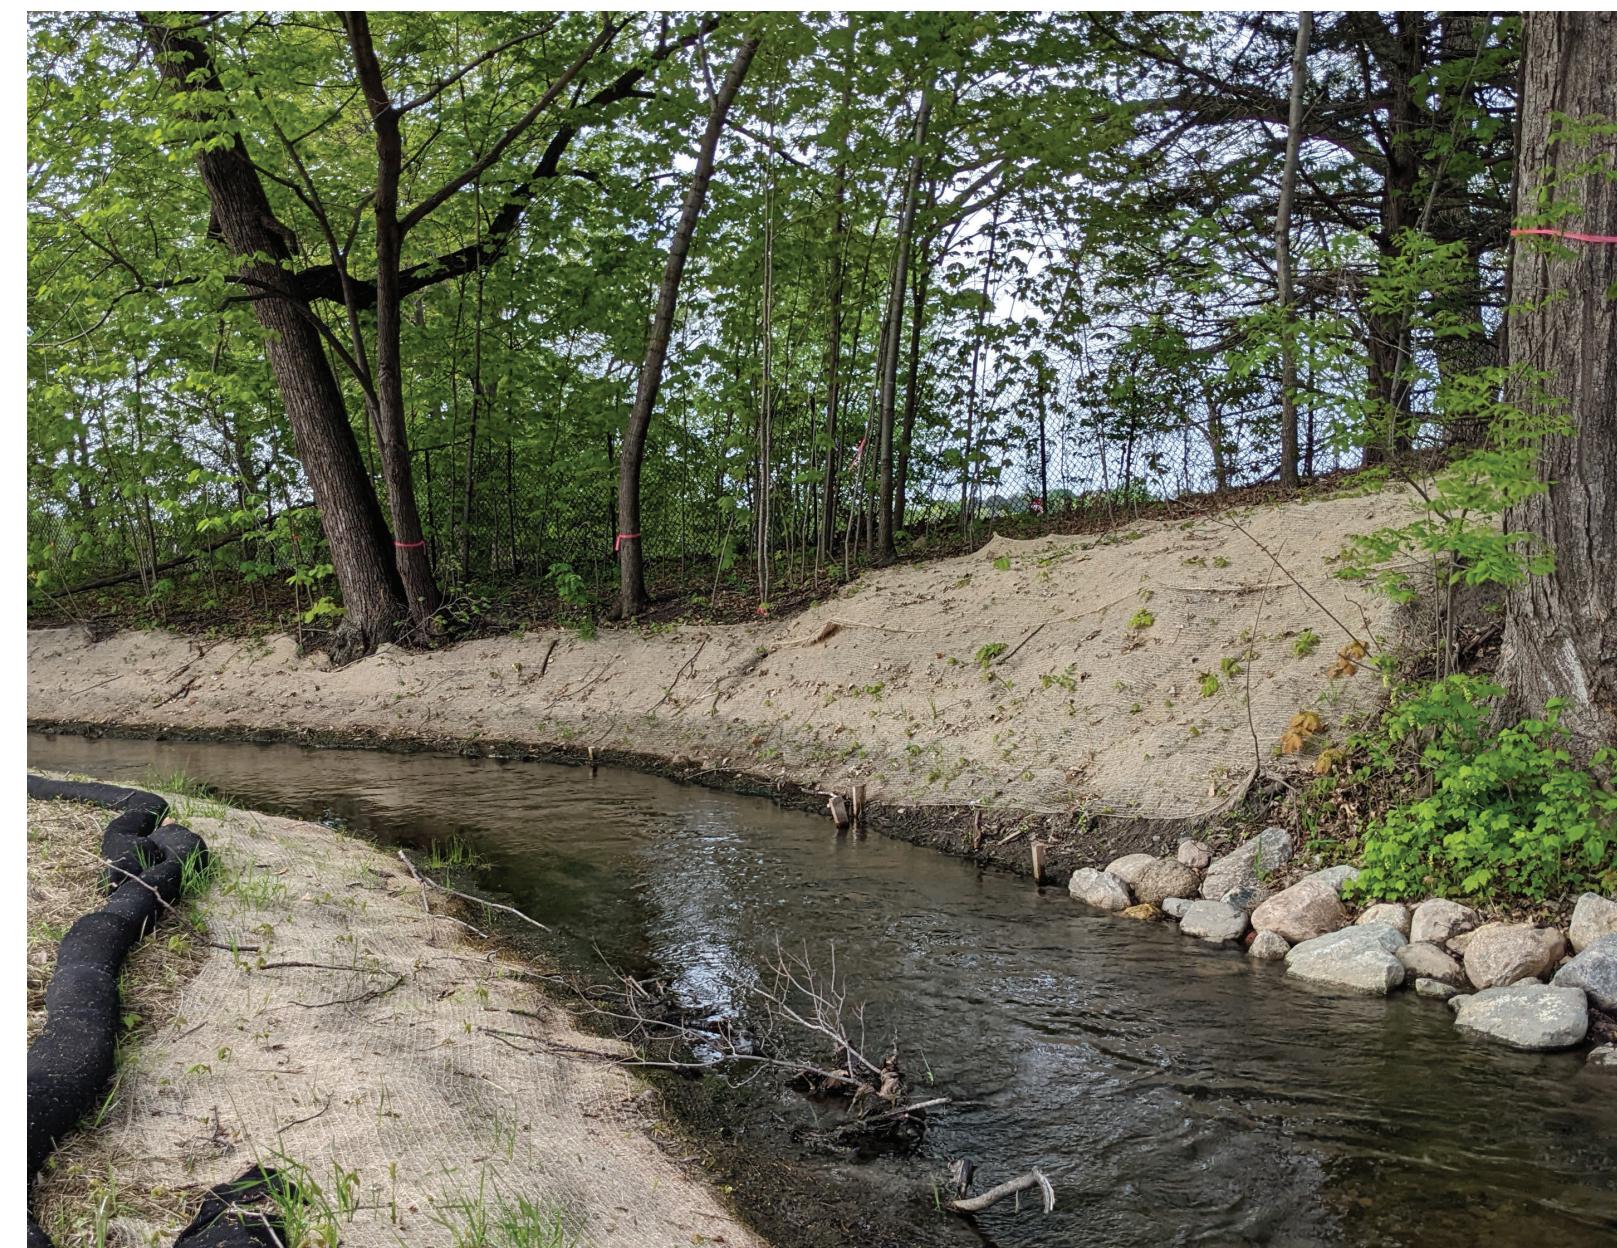
**Coir Log with Bank Grading**

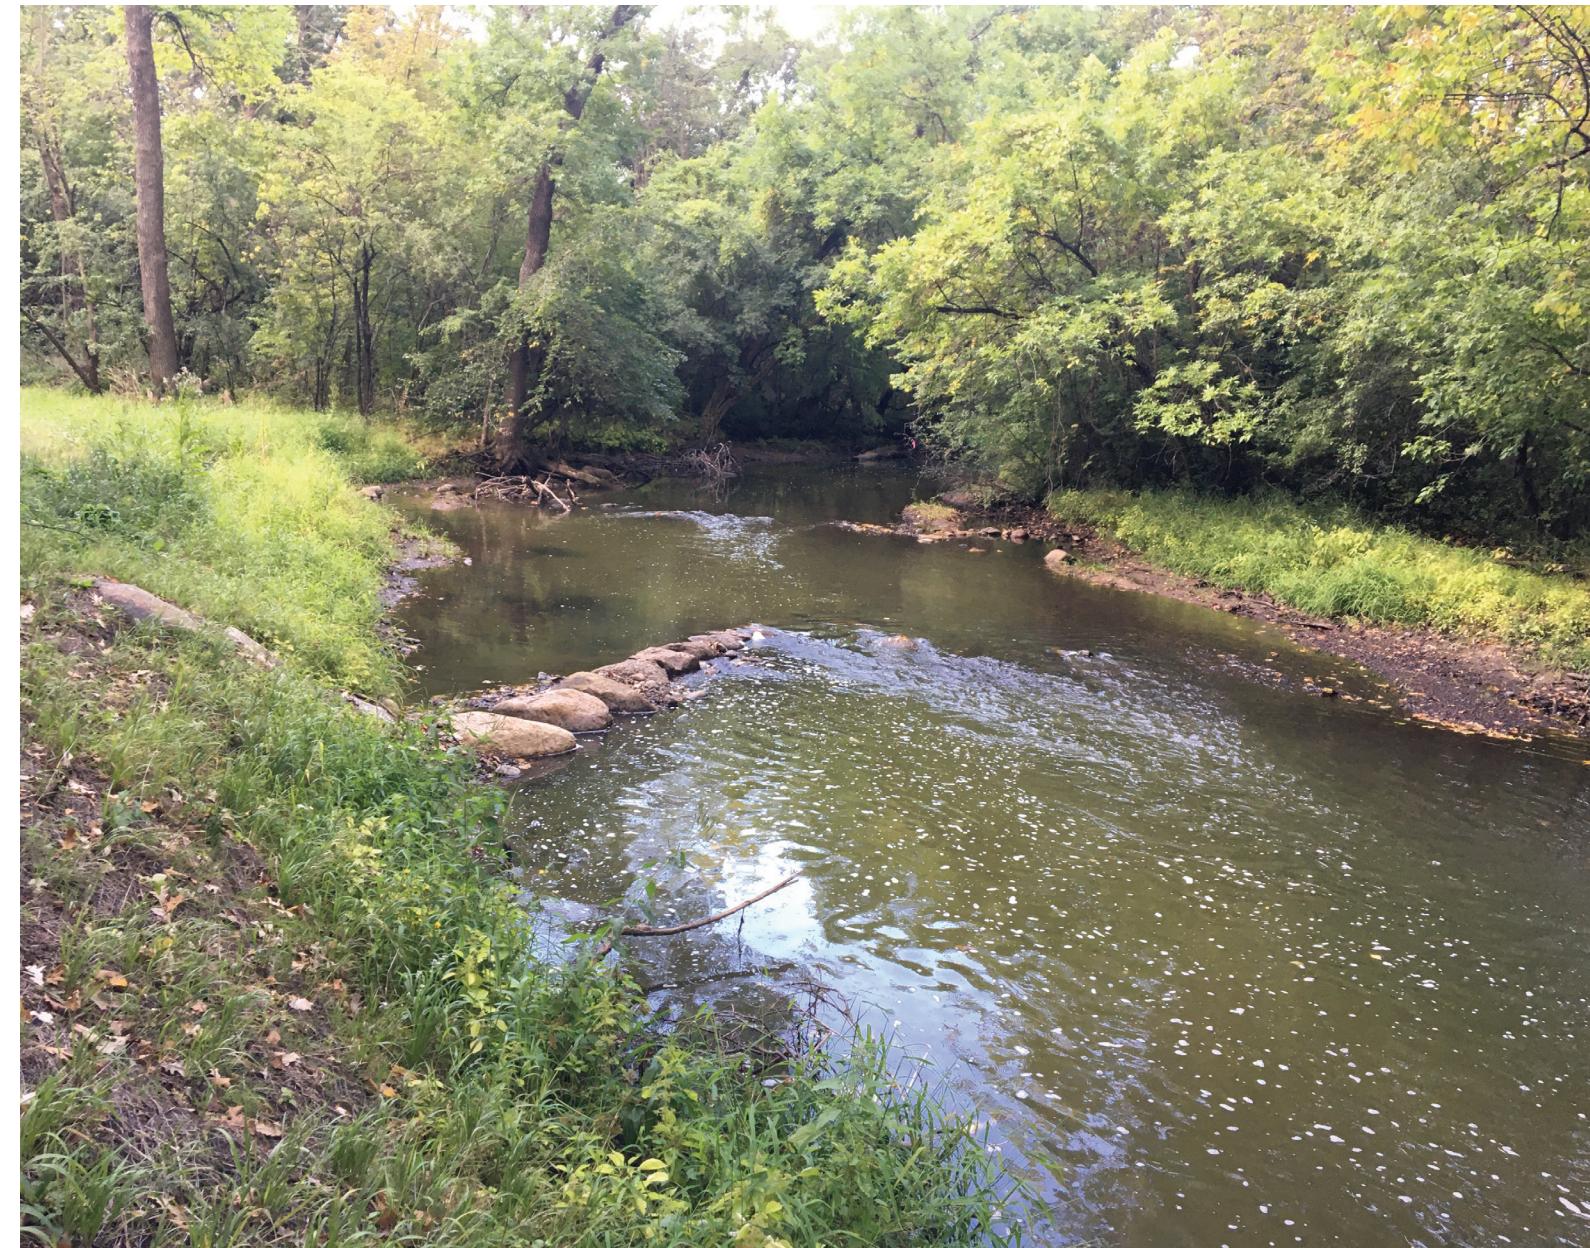
**J-hook**

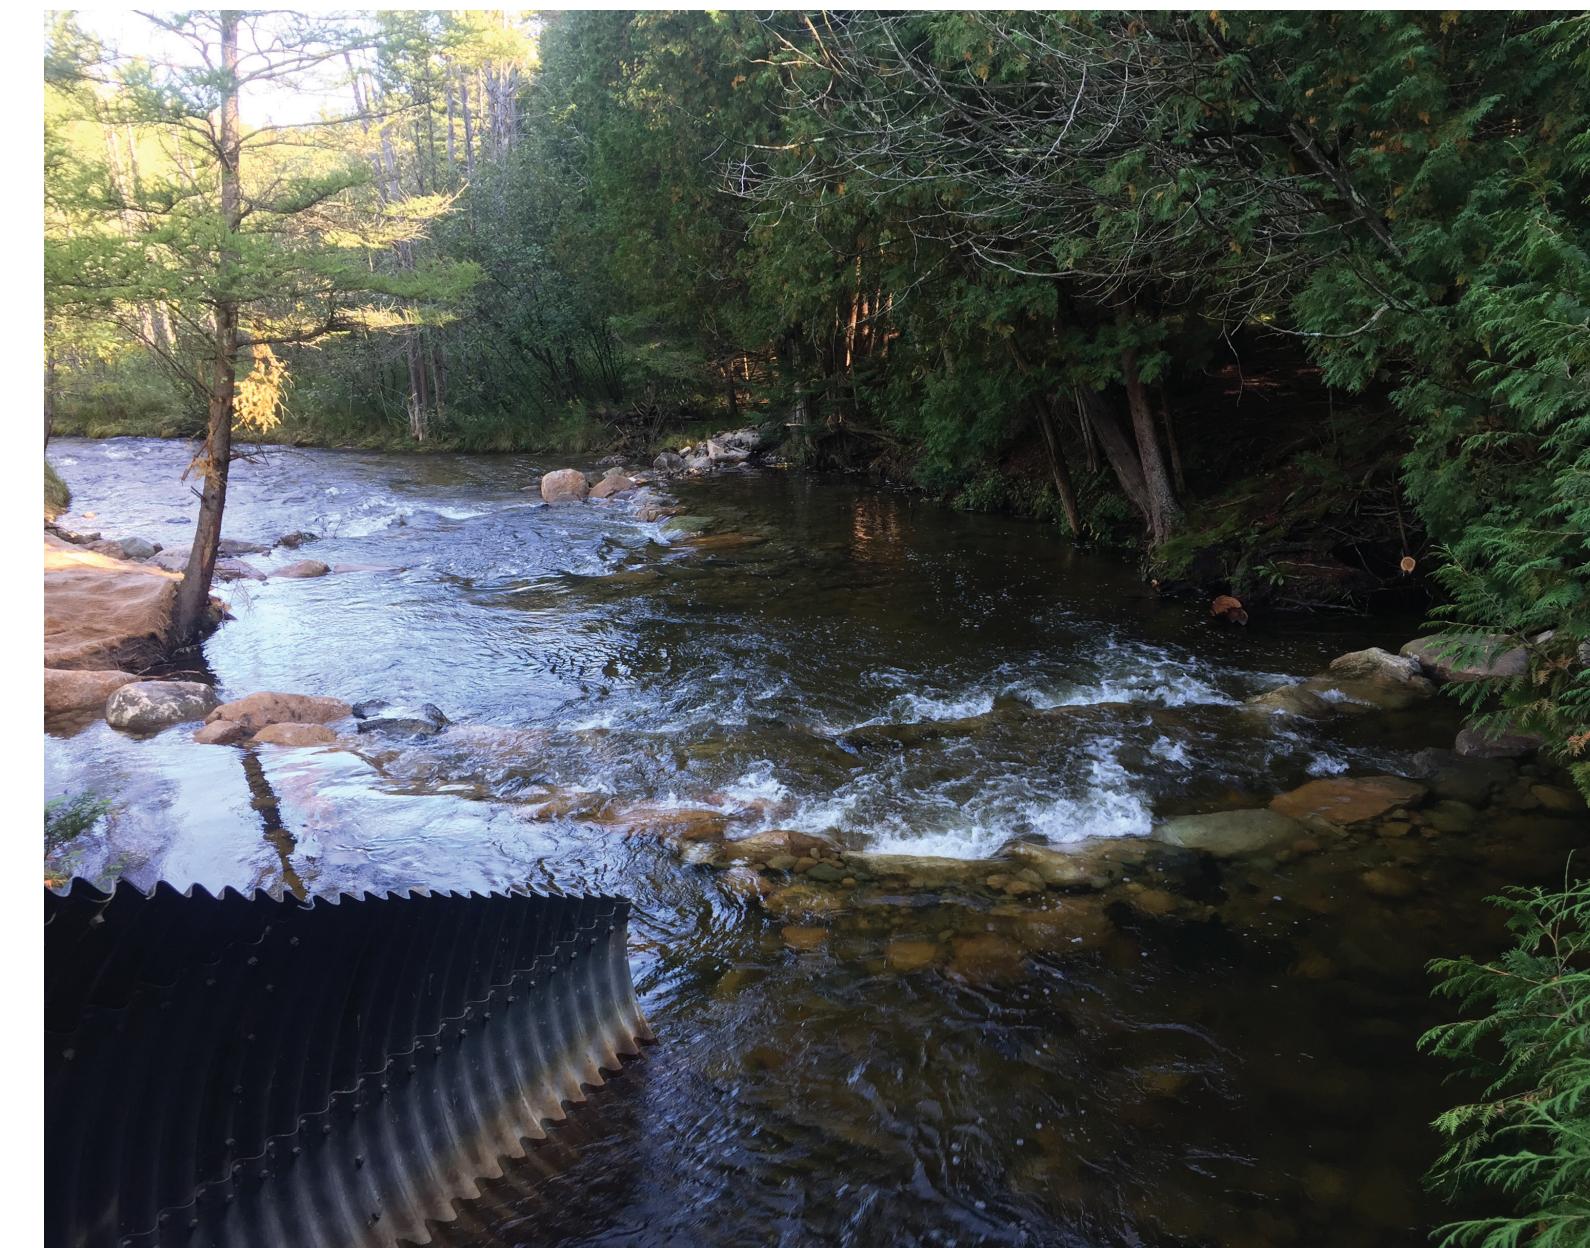
**Cross Vane**

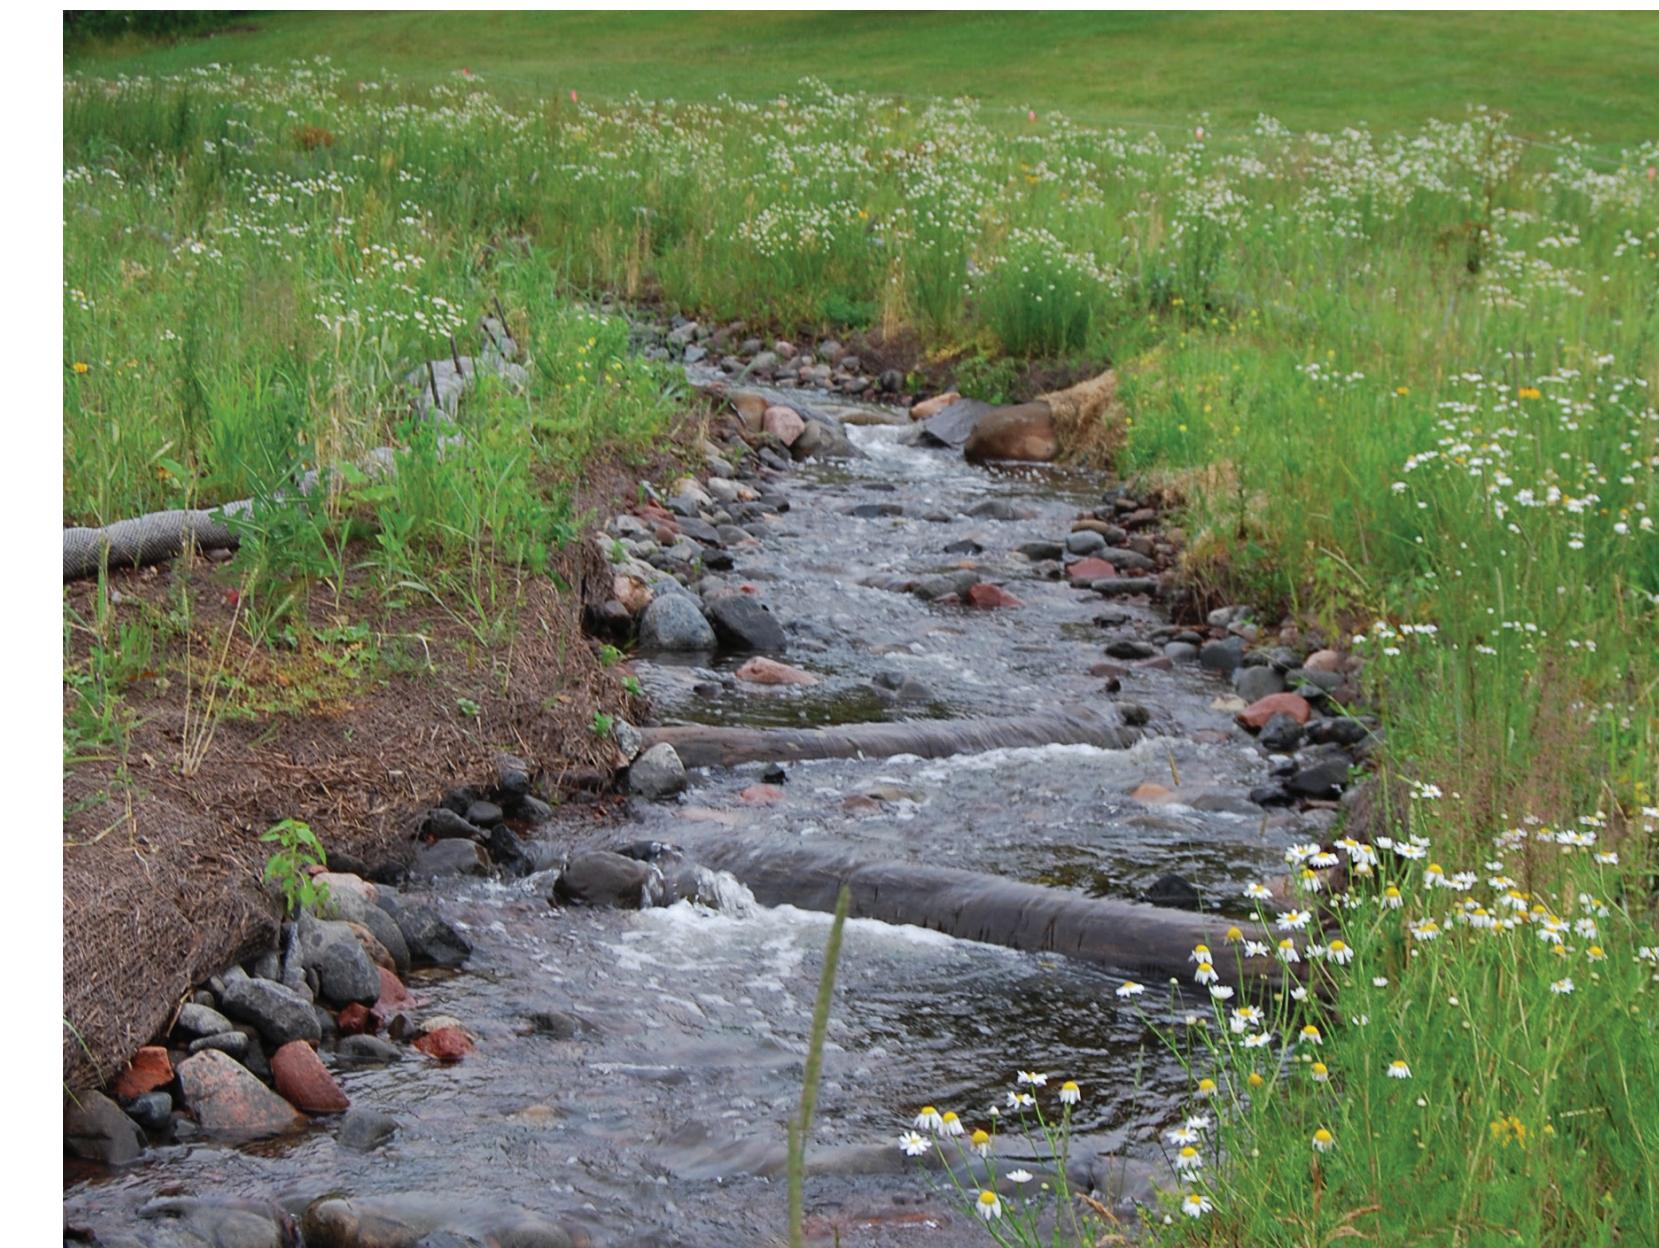
**Rock Toe with Log Vanes**

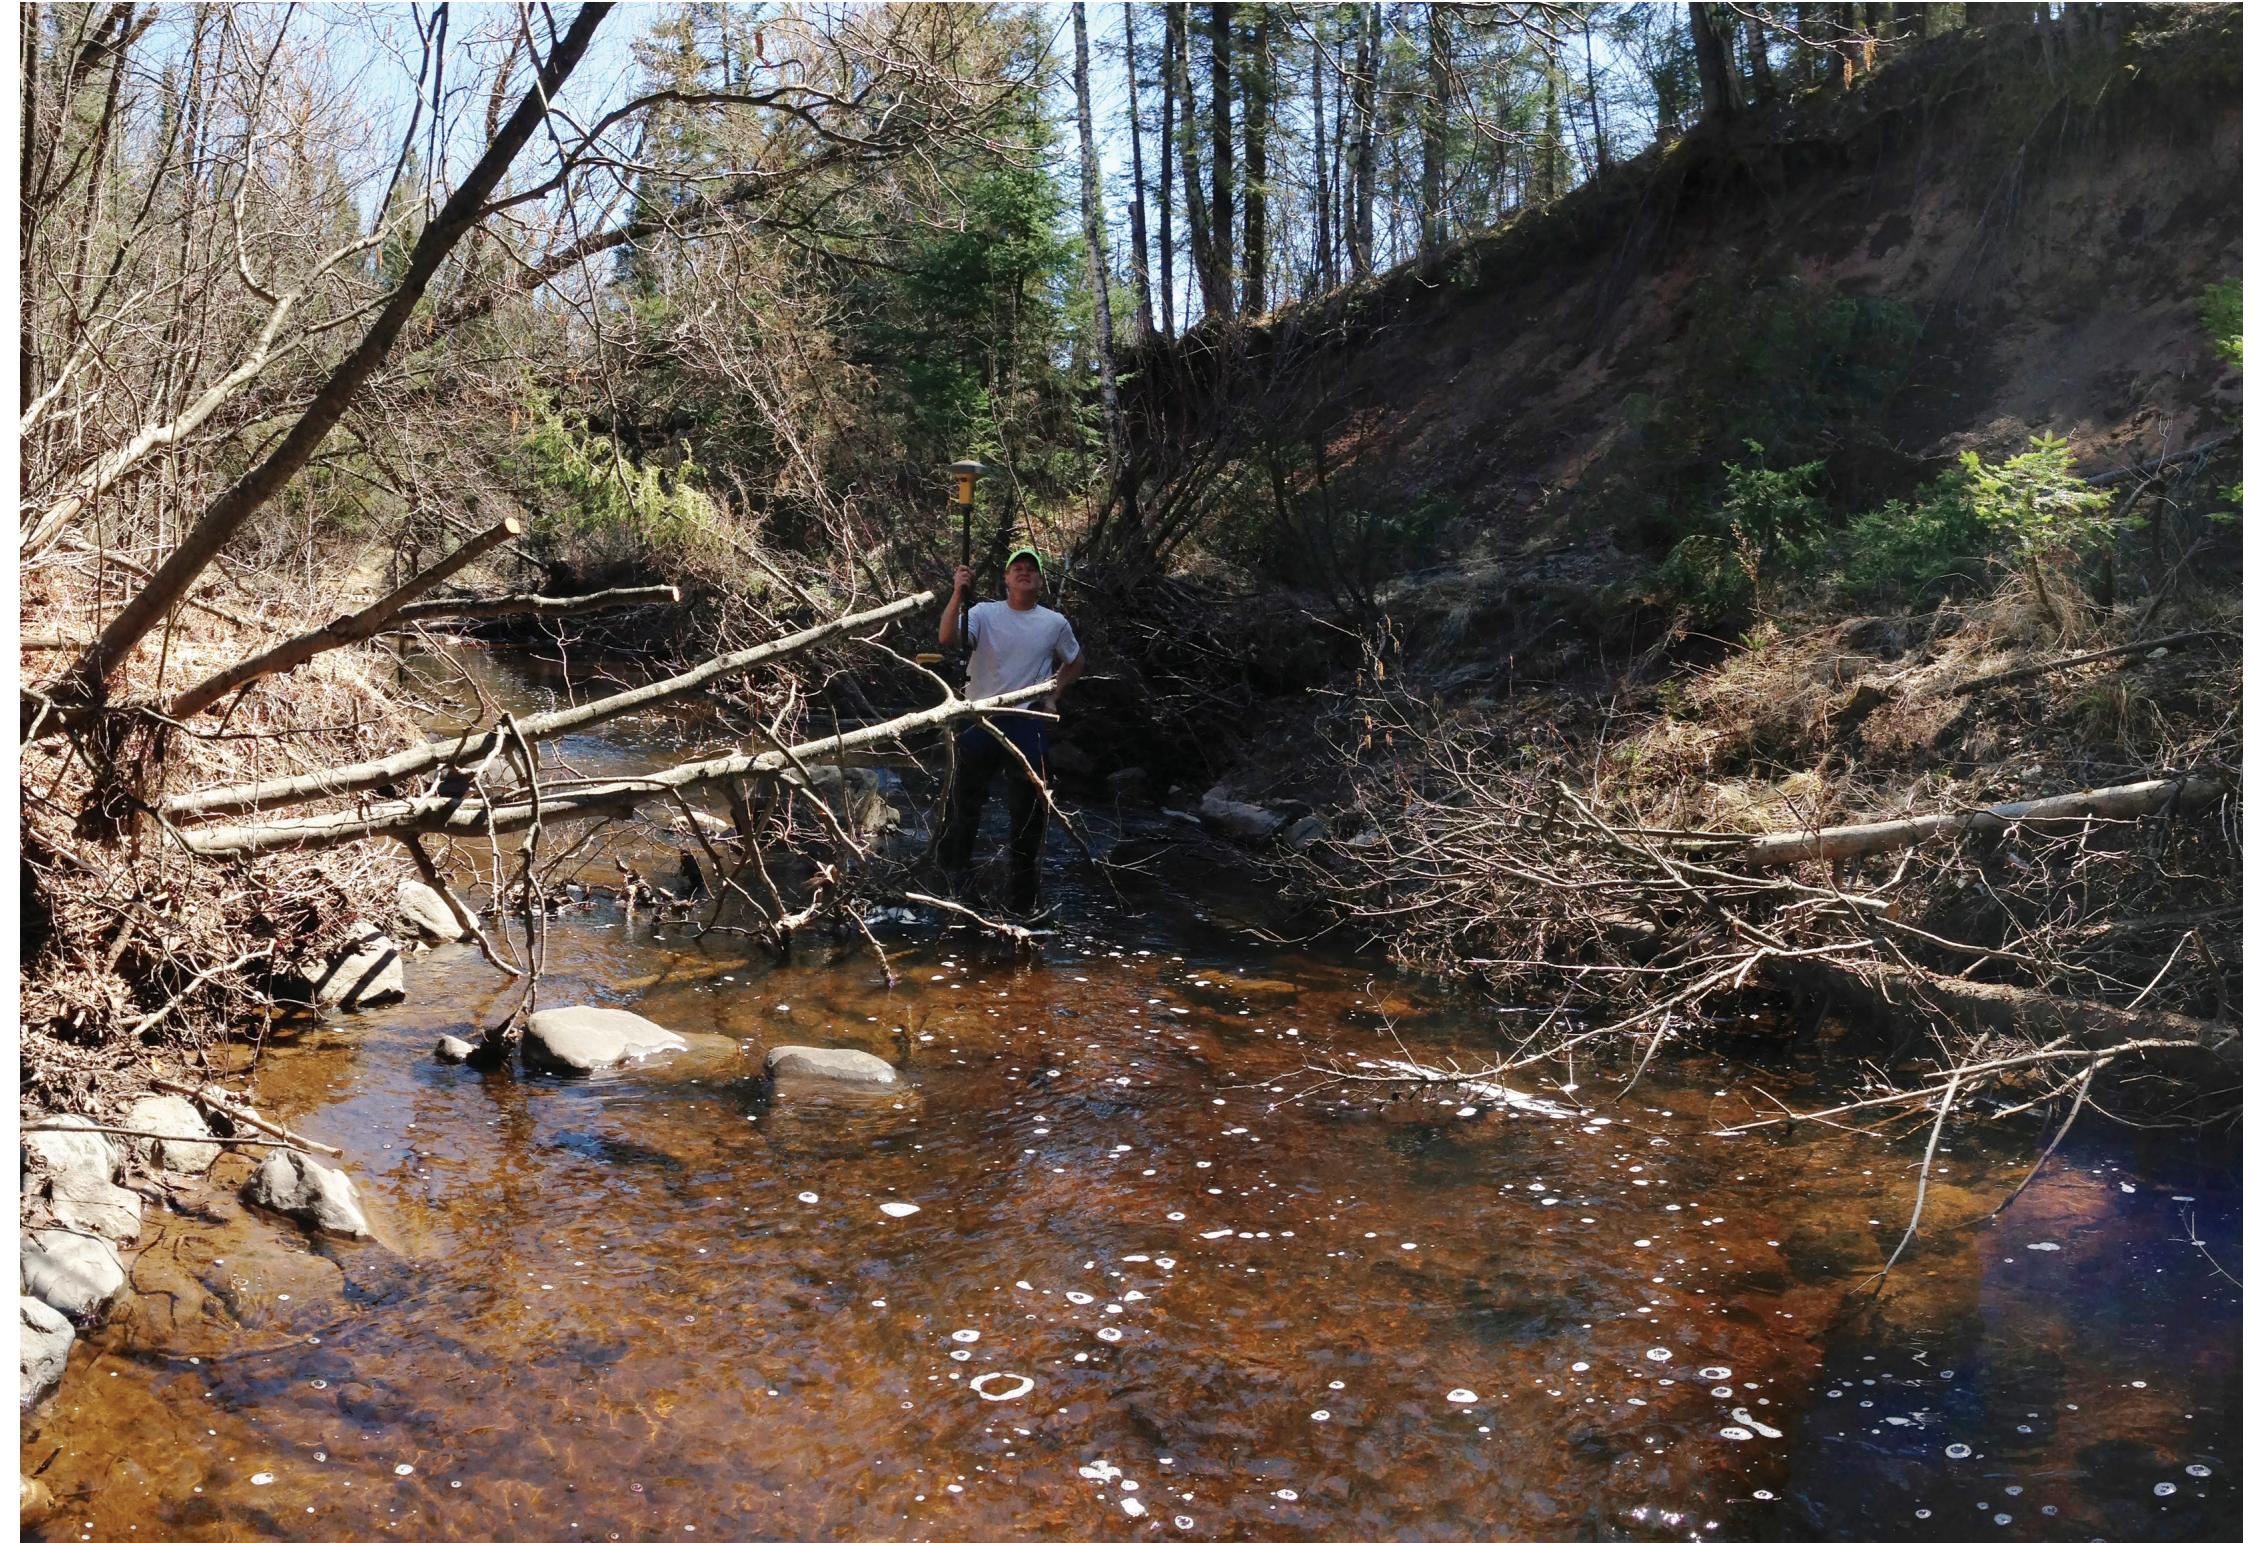
Before - Steep eroding bank with toe erosion and sloughing

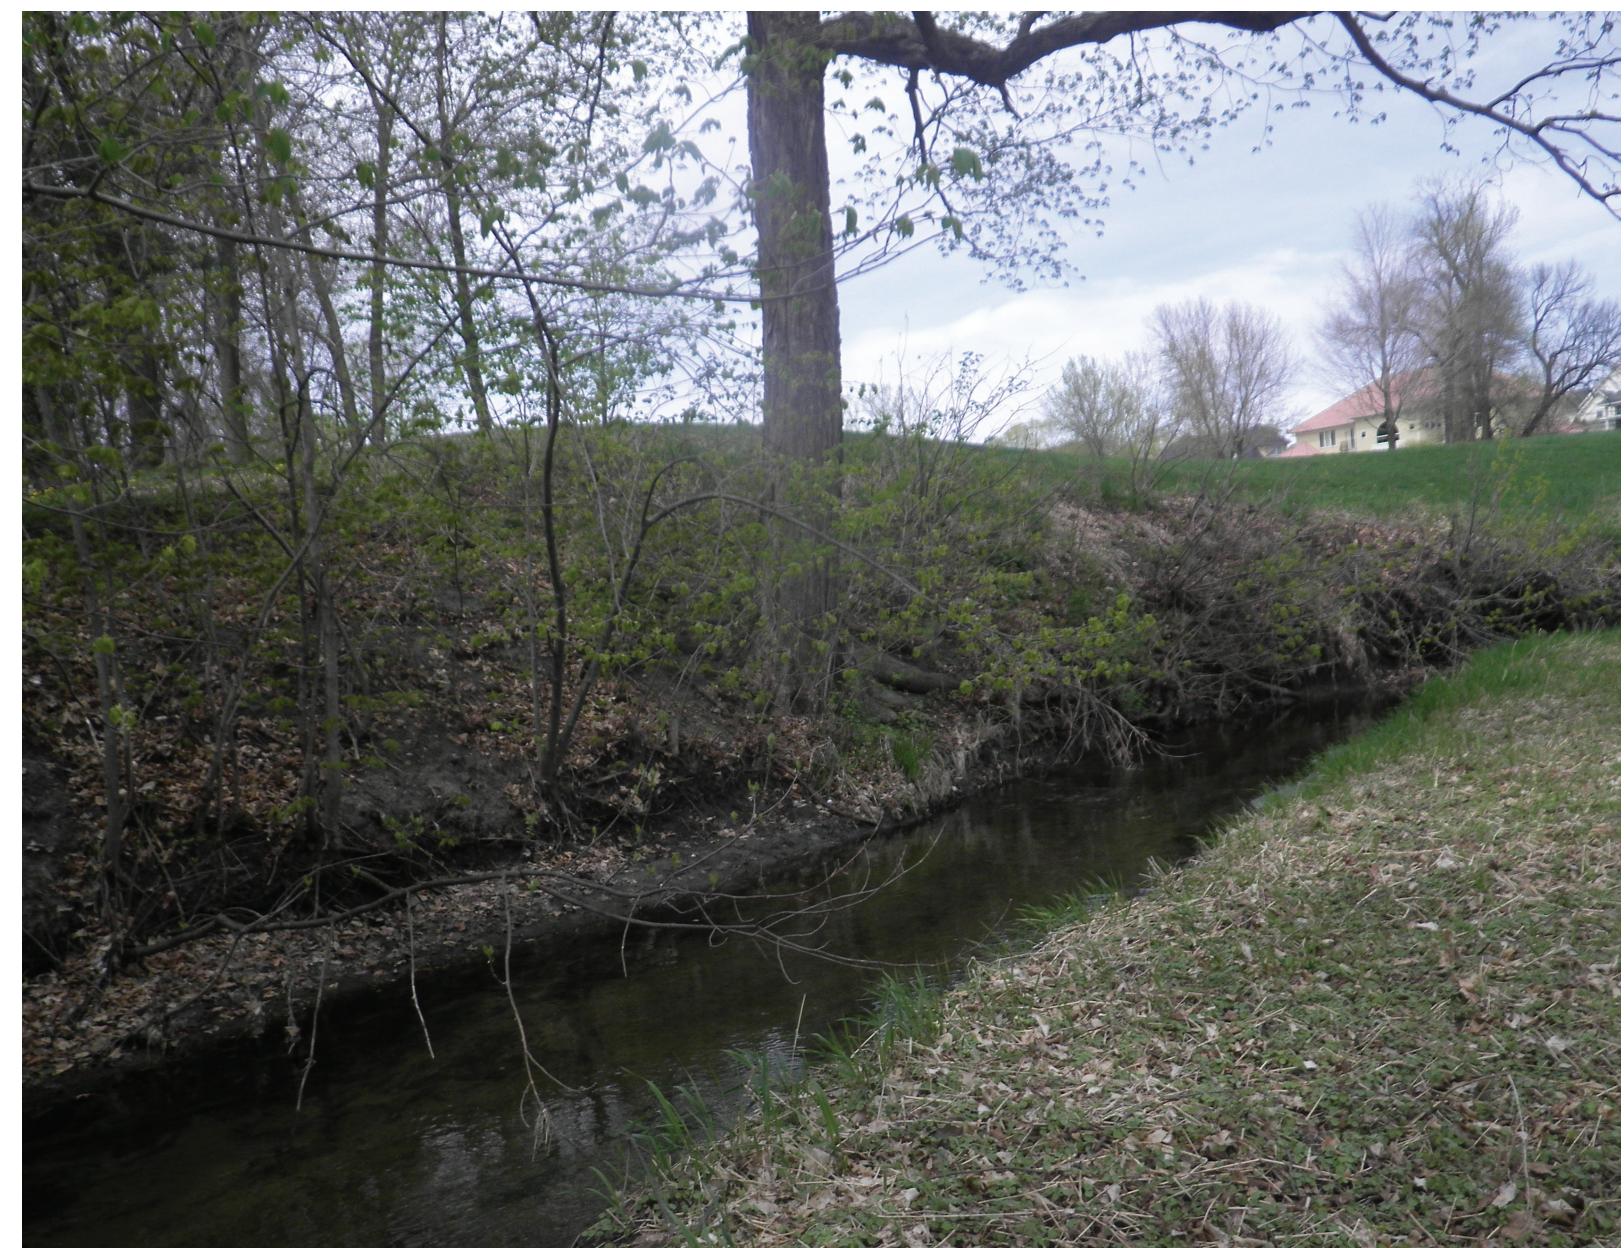
Before - undercut bank
