# About the Bassett Creek Watershed Management Commission (BCWMC)

# Bassett Creek Main Stem Erosion Issues and Restoration Prioritization

# 90% Design for Reach 1, Regent Avenue to Noble Avenue

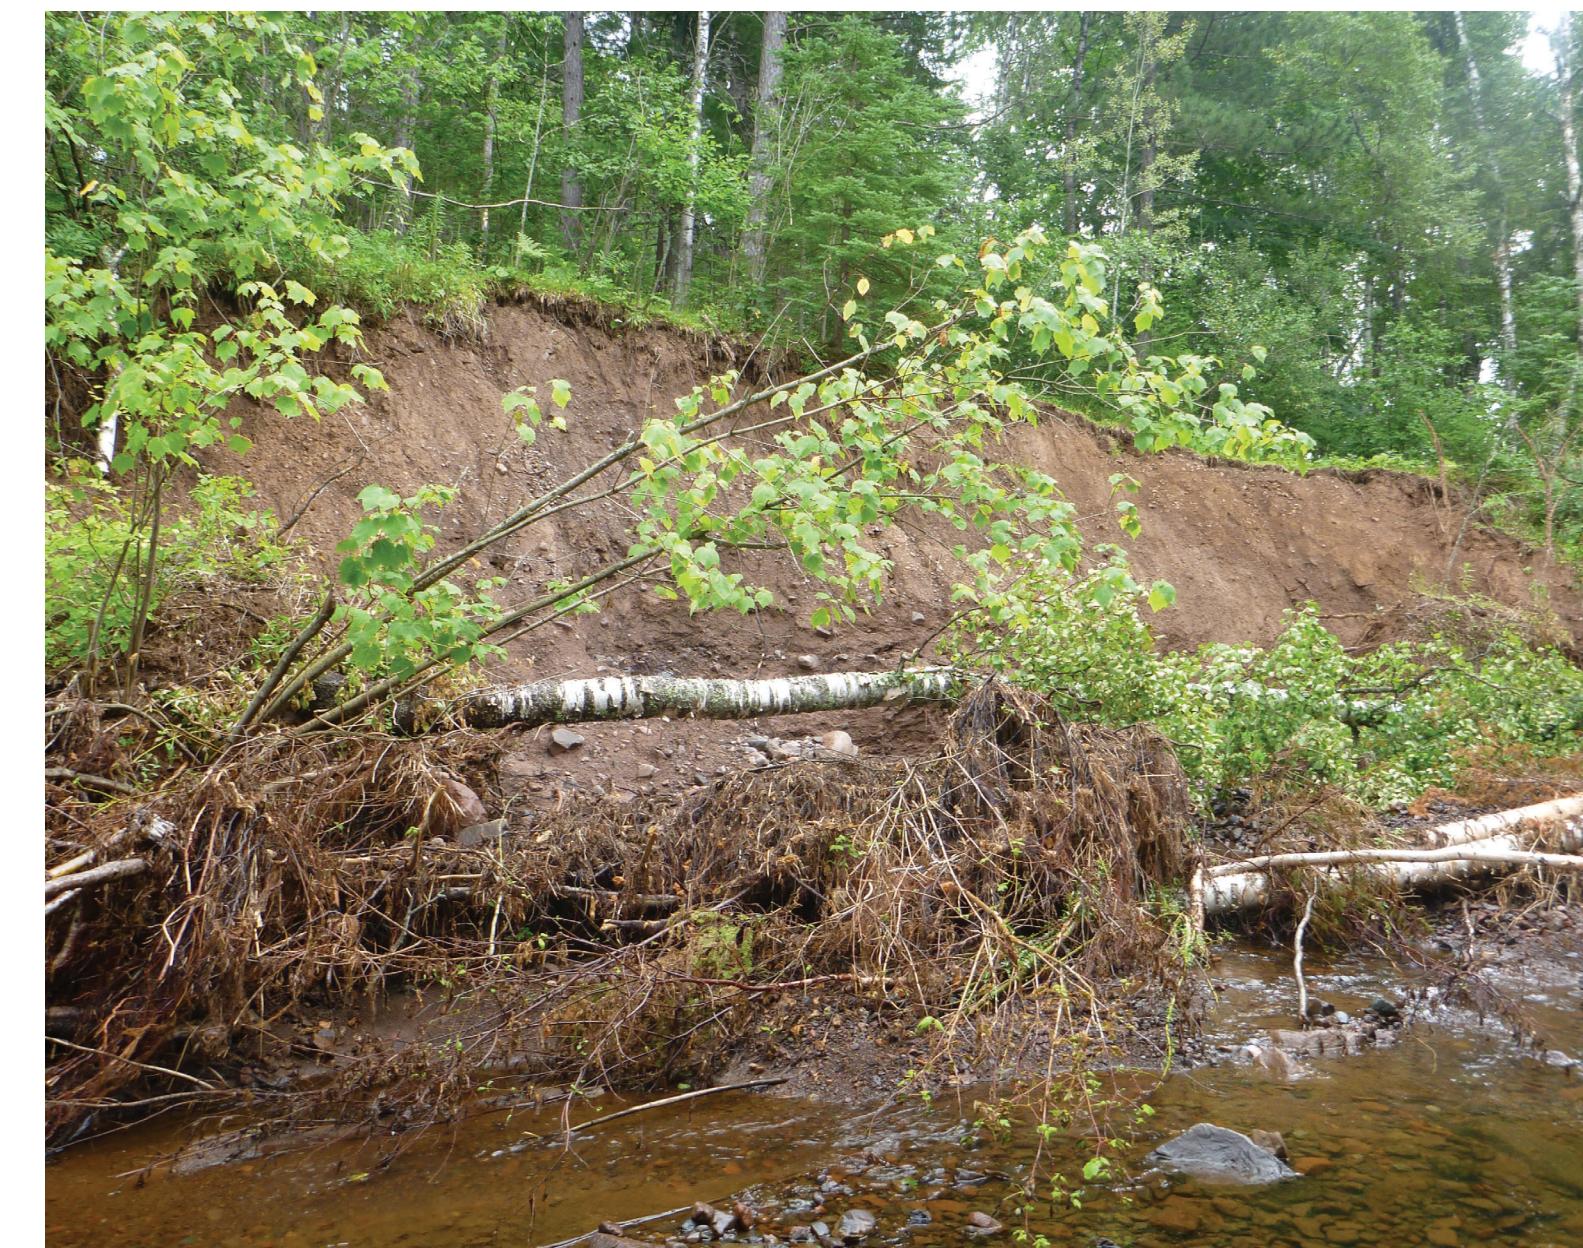
Before - steep, eroding bank with unstable toe

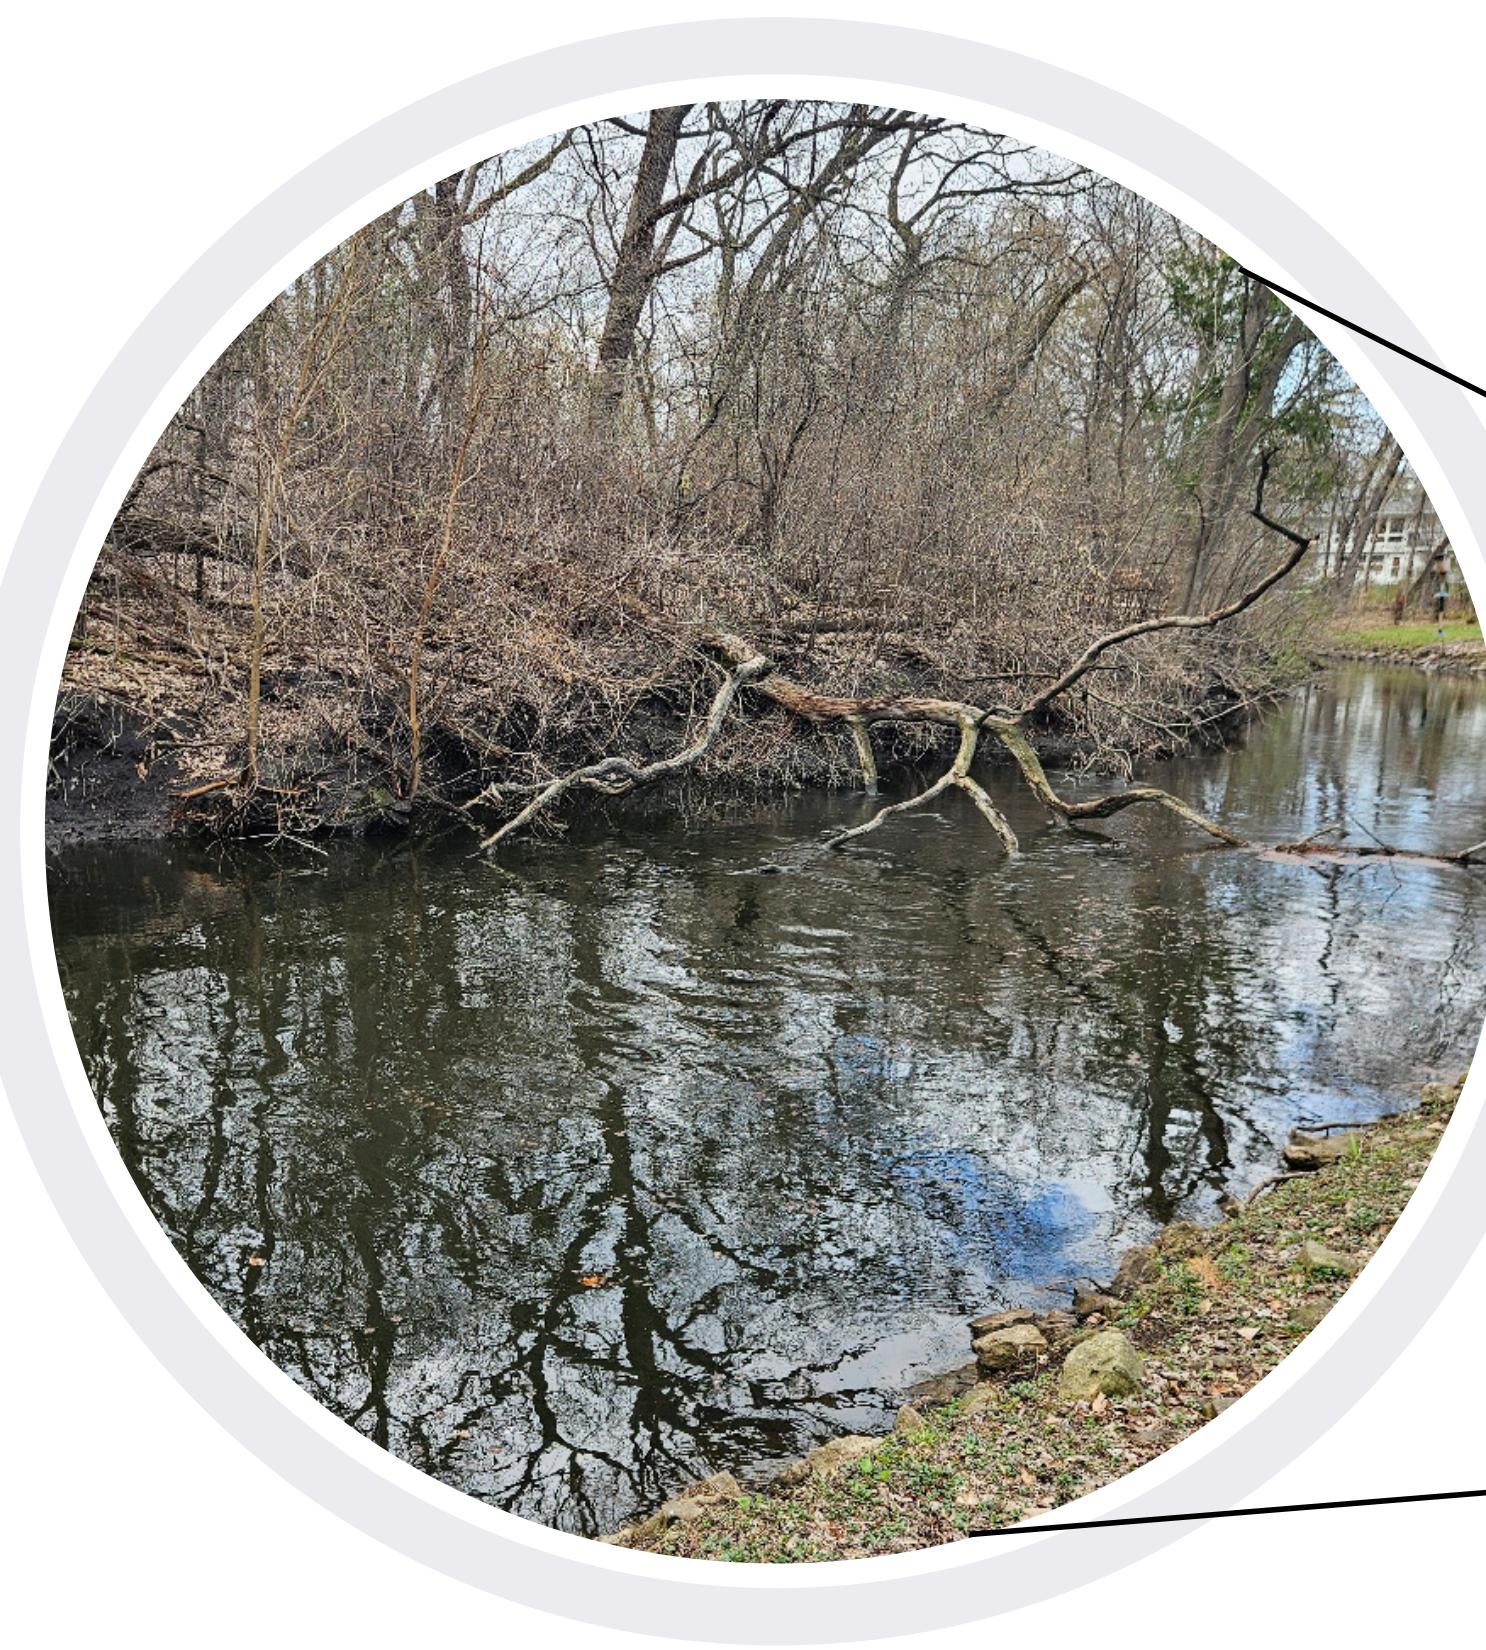
- Regrade channel and stream banks to improve floodplain connection
- Stabilize stream bank toe with rock riprap, toe wood, and fascines
- Install J-hook vanes to maintain channel grade and route erosive flows away from stream banks
- Grade and restore washed out gully

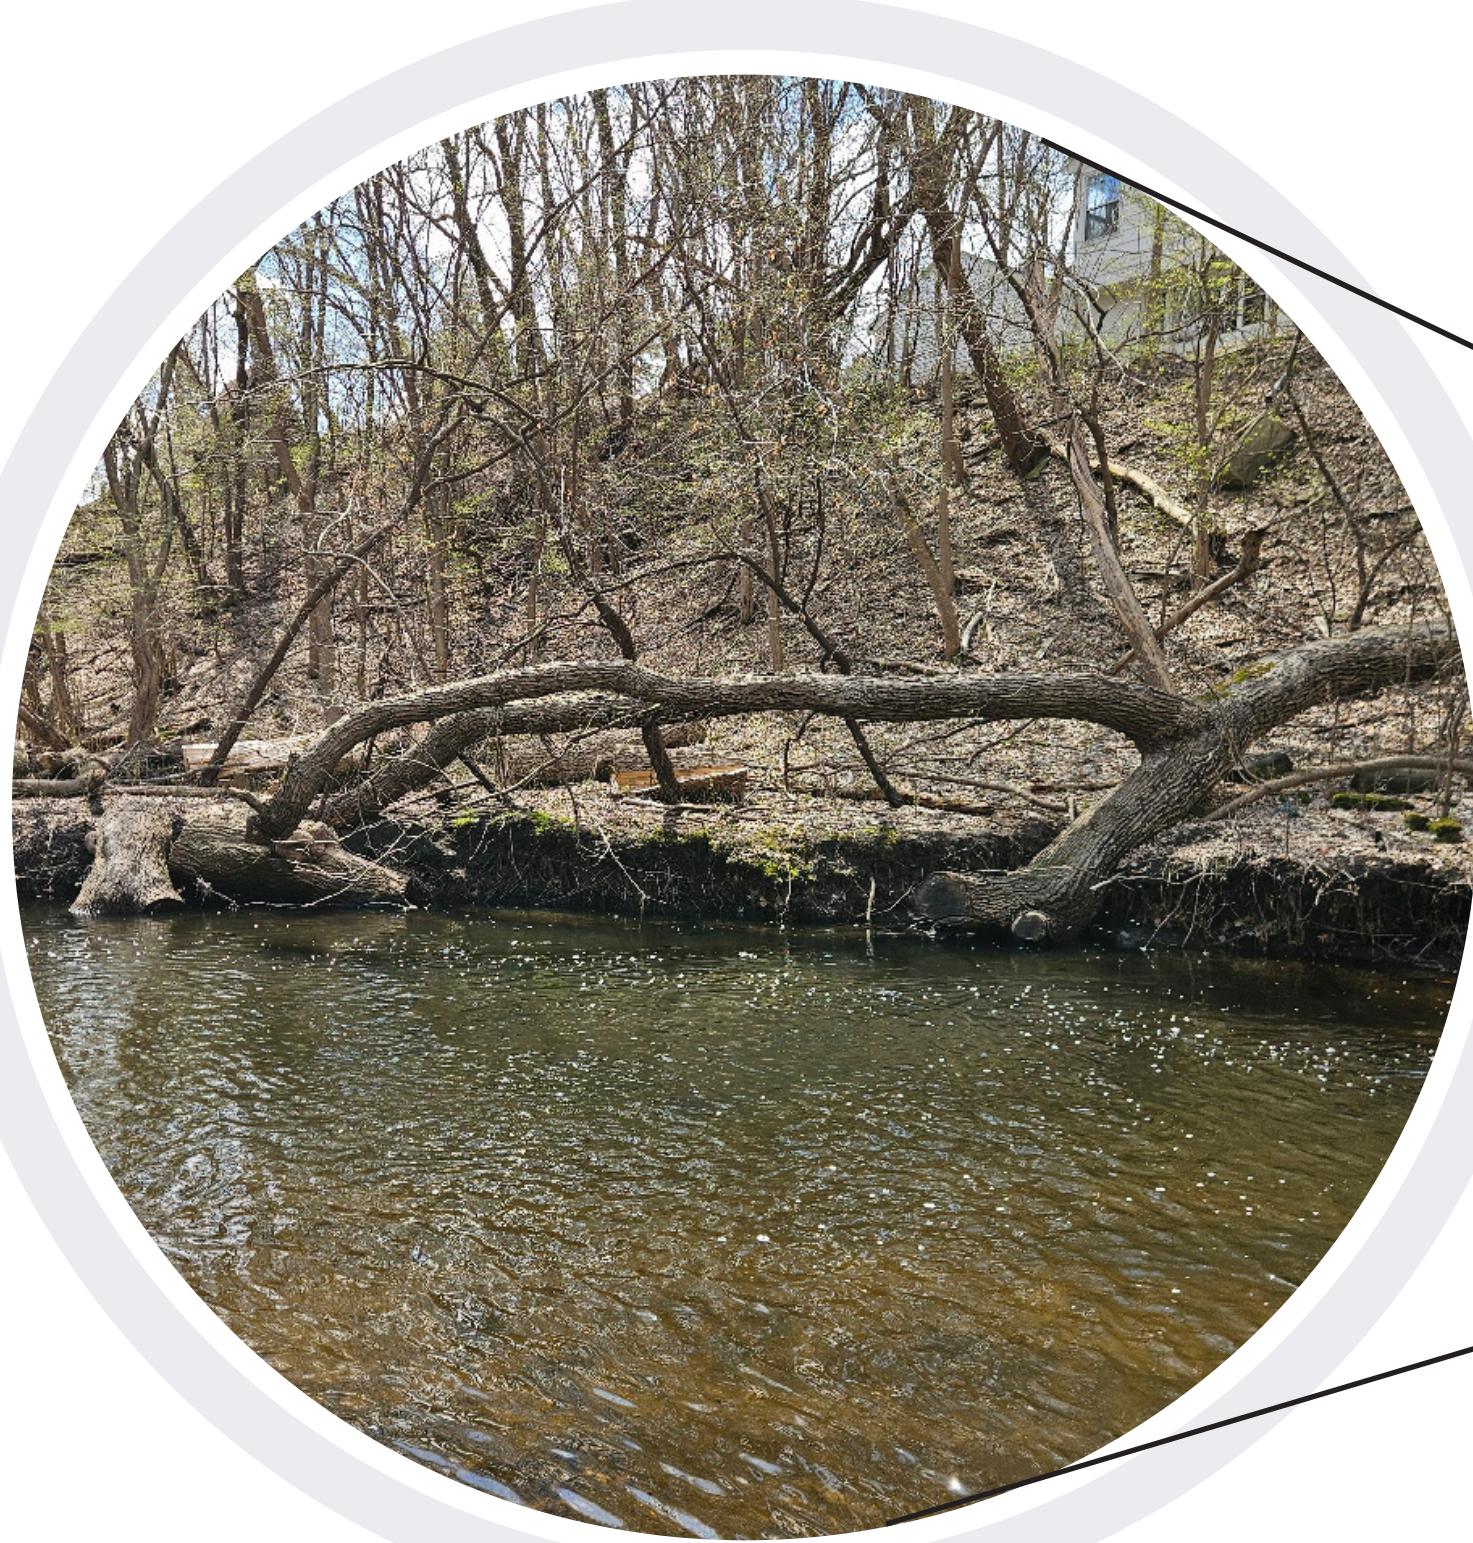
# 90% Design for Reach 2, Noble Avenue to Bassett Creek Drive

- Install cross vanes to provide protection for sanitary sewer crossings
- Stabilize stream bank toe with rock riprap, toe wood, and fascines
- Regrade channel and stream banks to improve floodplain connection
- Stabilize stream bank with vegetative material (seed, live plugs, shrubs, and/or live cuttings)

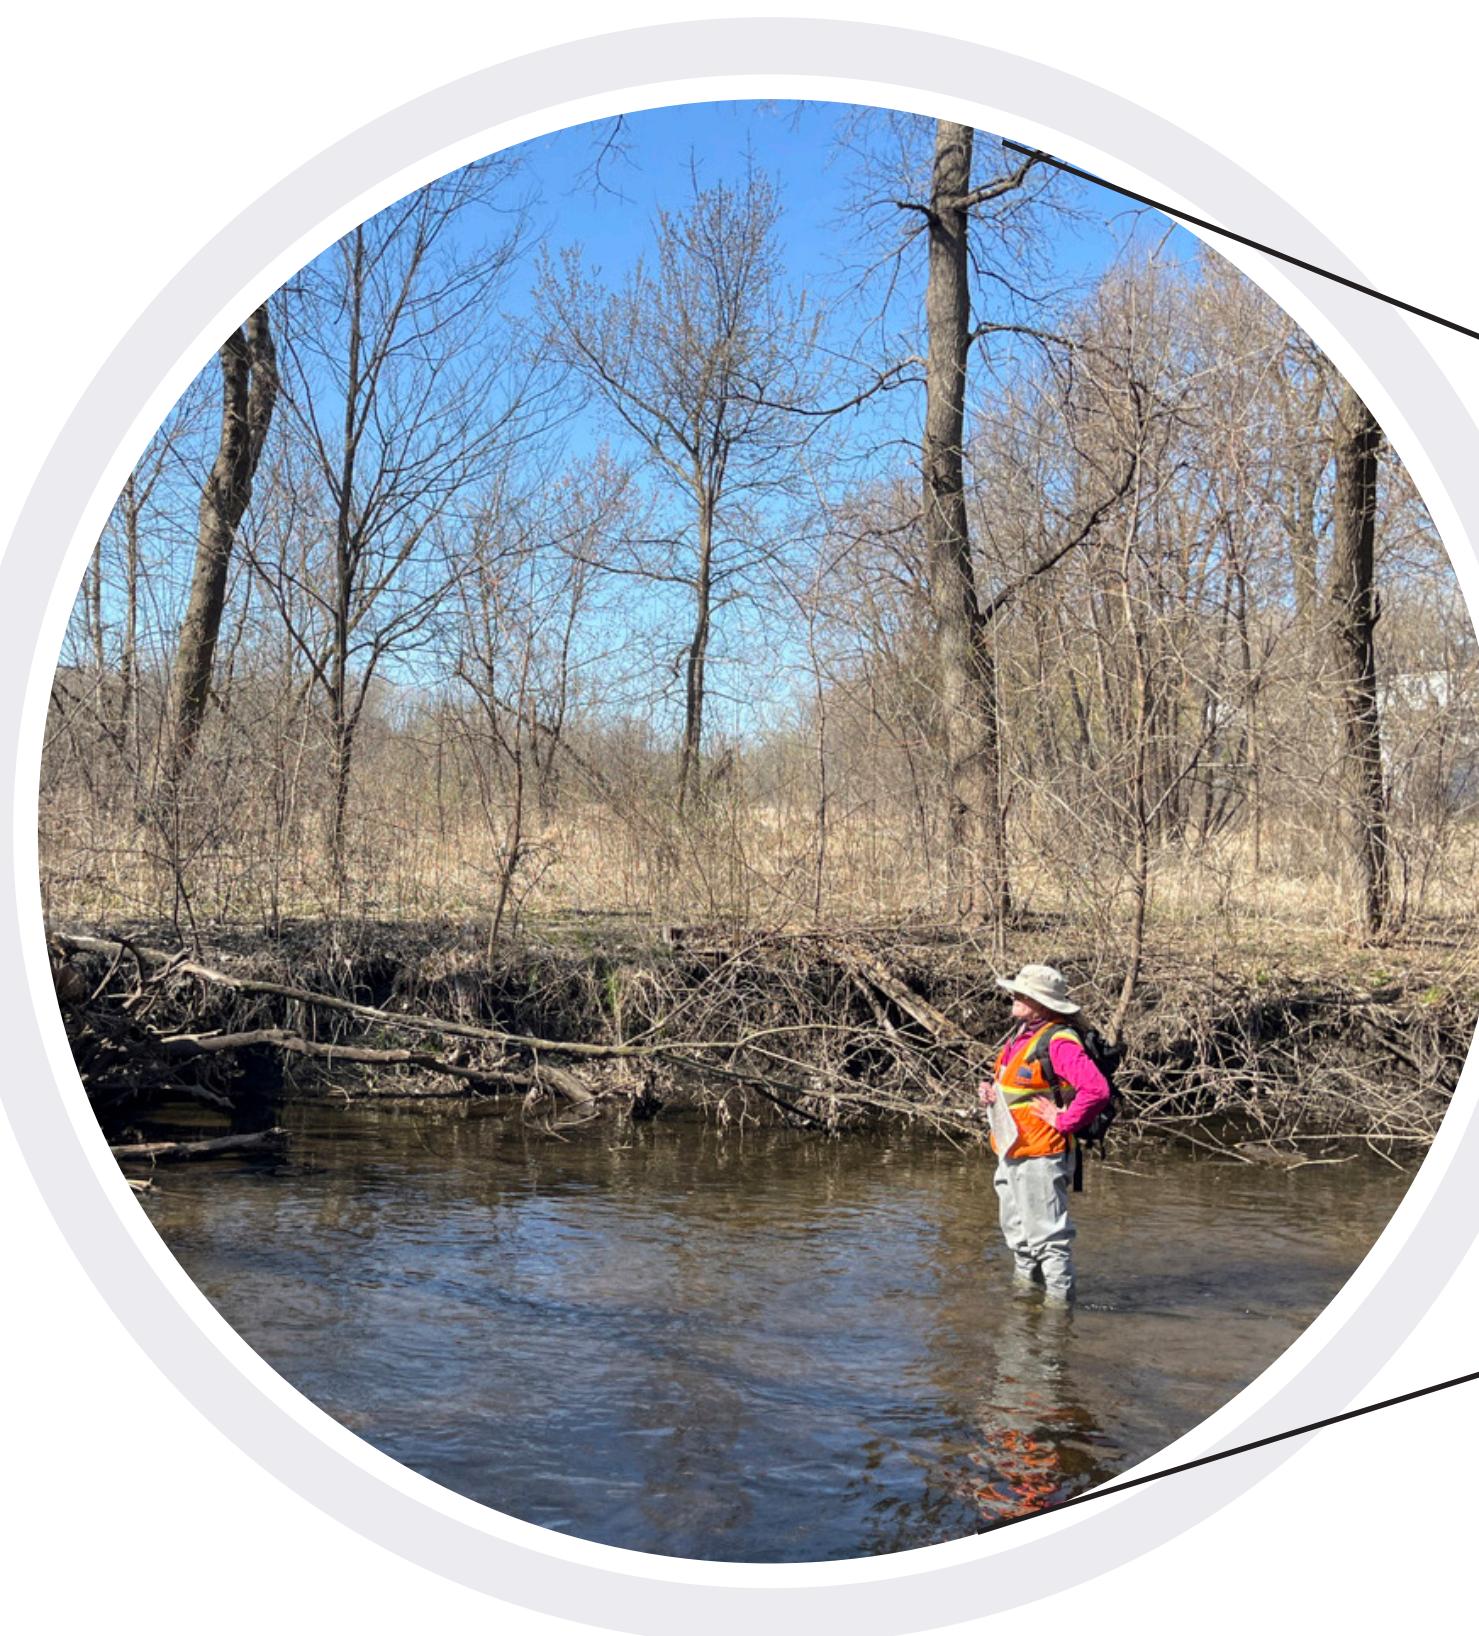
# 90% Design for Reach 3, Bassett Creek Drive to Station 61+00

- Regrade channel and stream banks to improve floodplain connection
- Stabilize stream bank with vegetative material (seed, live plugs, shrubs, and/or live cuttings)
- Install cross vanes to prevent erosion upstream and downstream of road and bridge crossings
- Install J-Hooks to route erosive flows away from the bank and towards the center of the channel

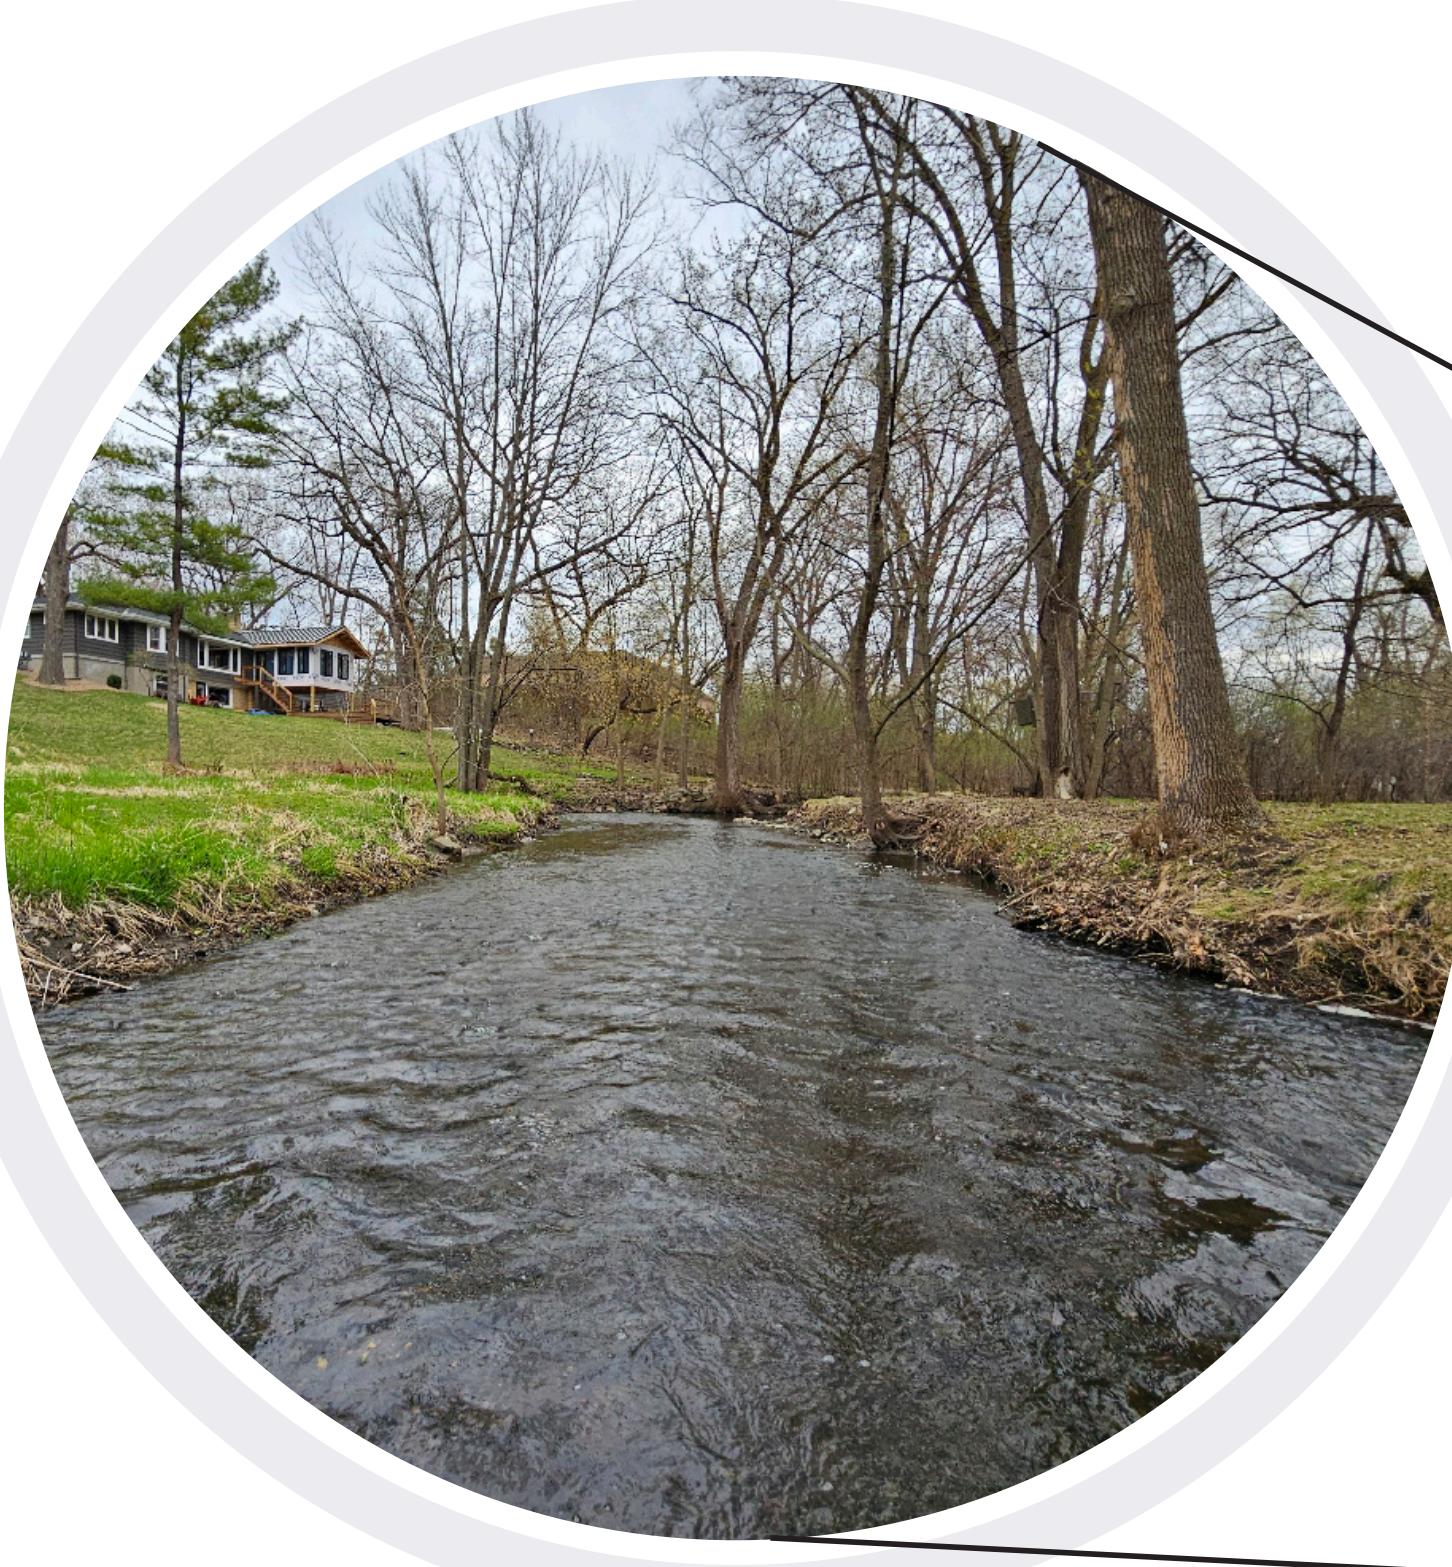
# 90% Design for Reach 4, Station 61+00 to Golden Valley Road

- Regrade channel and stream banks to improve floodplain connection
- Stabilize stream bank with vegetative material (seed, live plugs, shrubs, and/or live cuttings)
- Install cross vanes to maintain channel grade and j-hook vanes to route erosive flows away from stream banks, especially those that have sanitary sewer
- Stabilize stream bank toe with rock riprap, toe wood, facines, and coir log

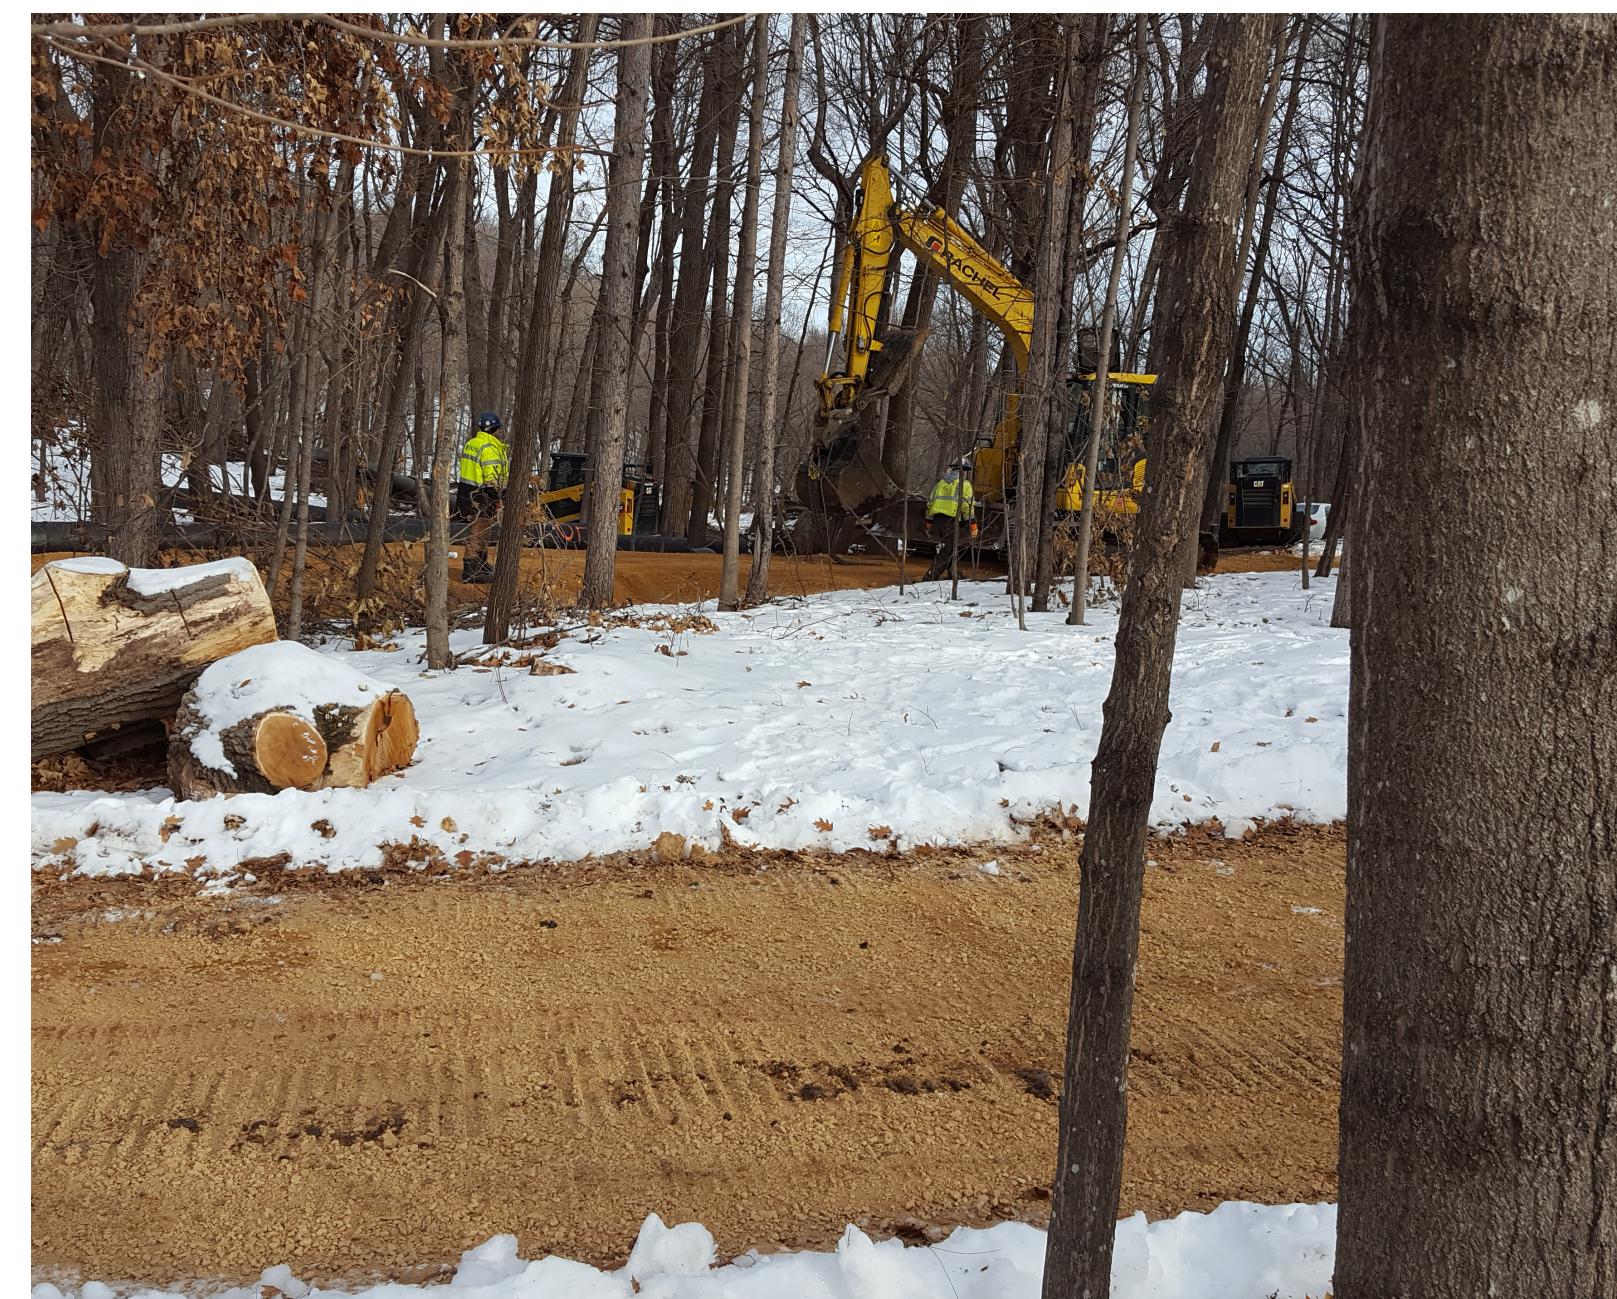
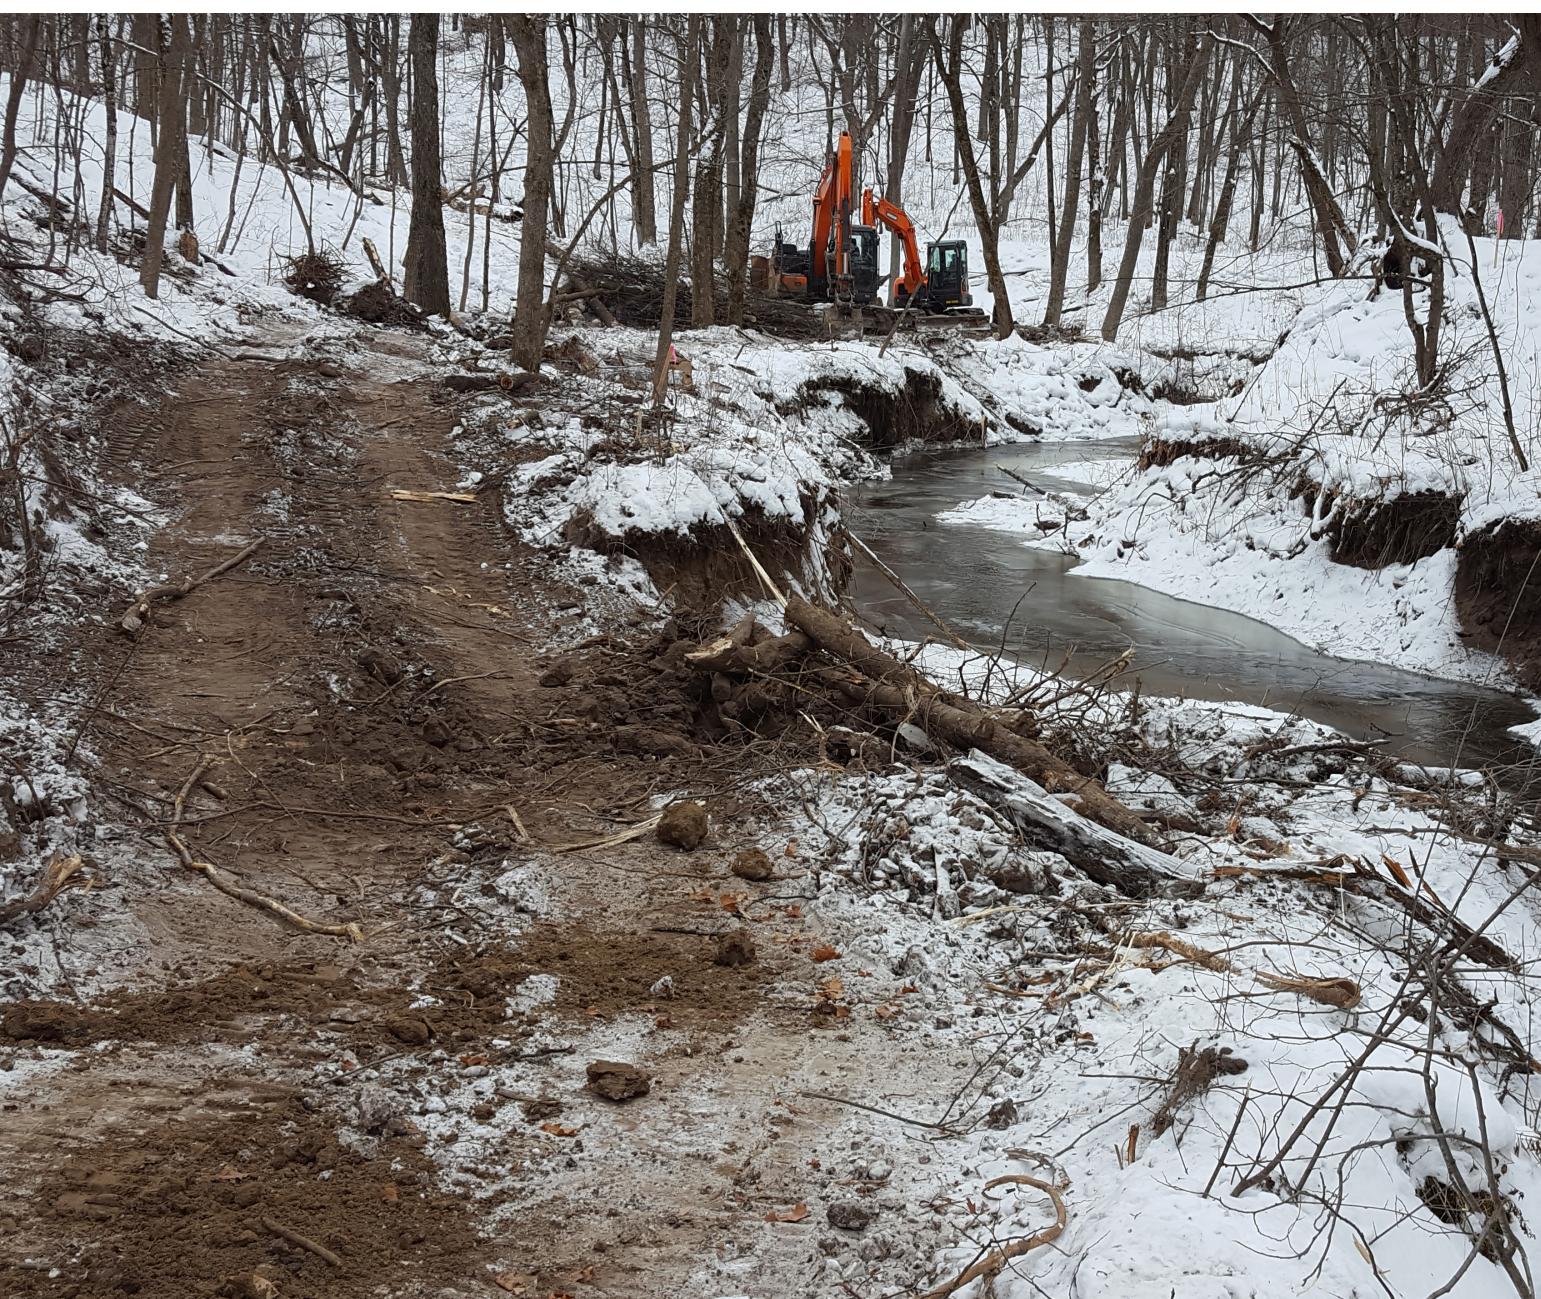
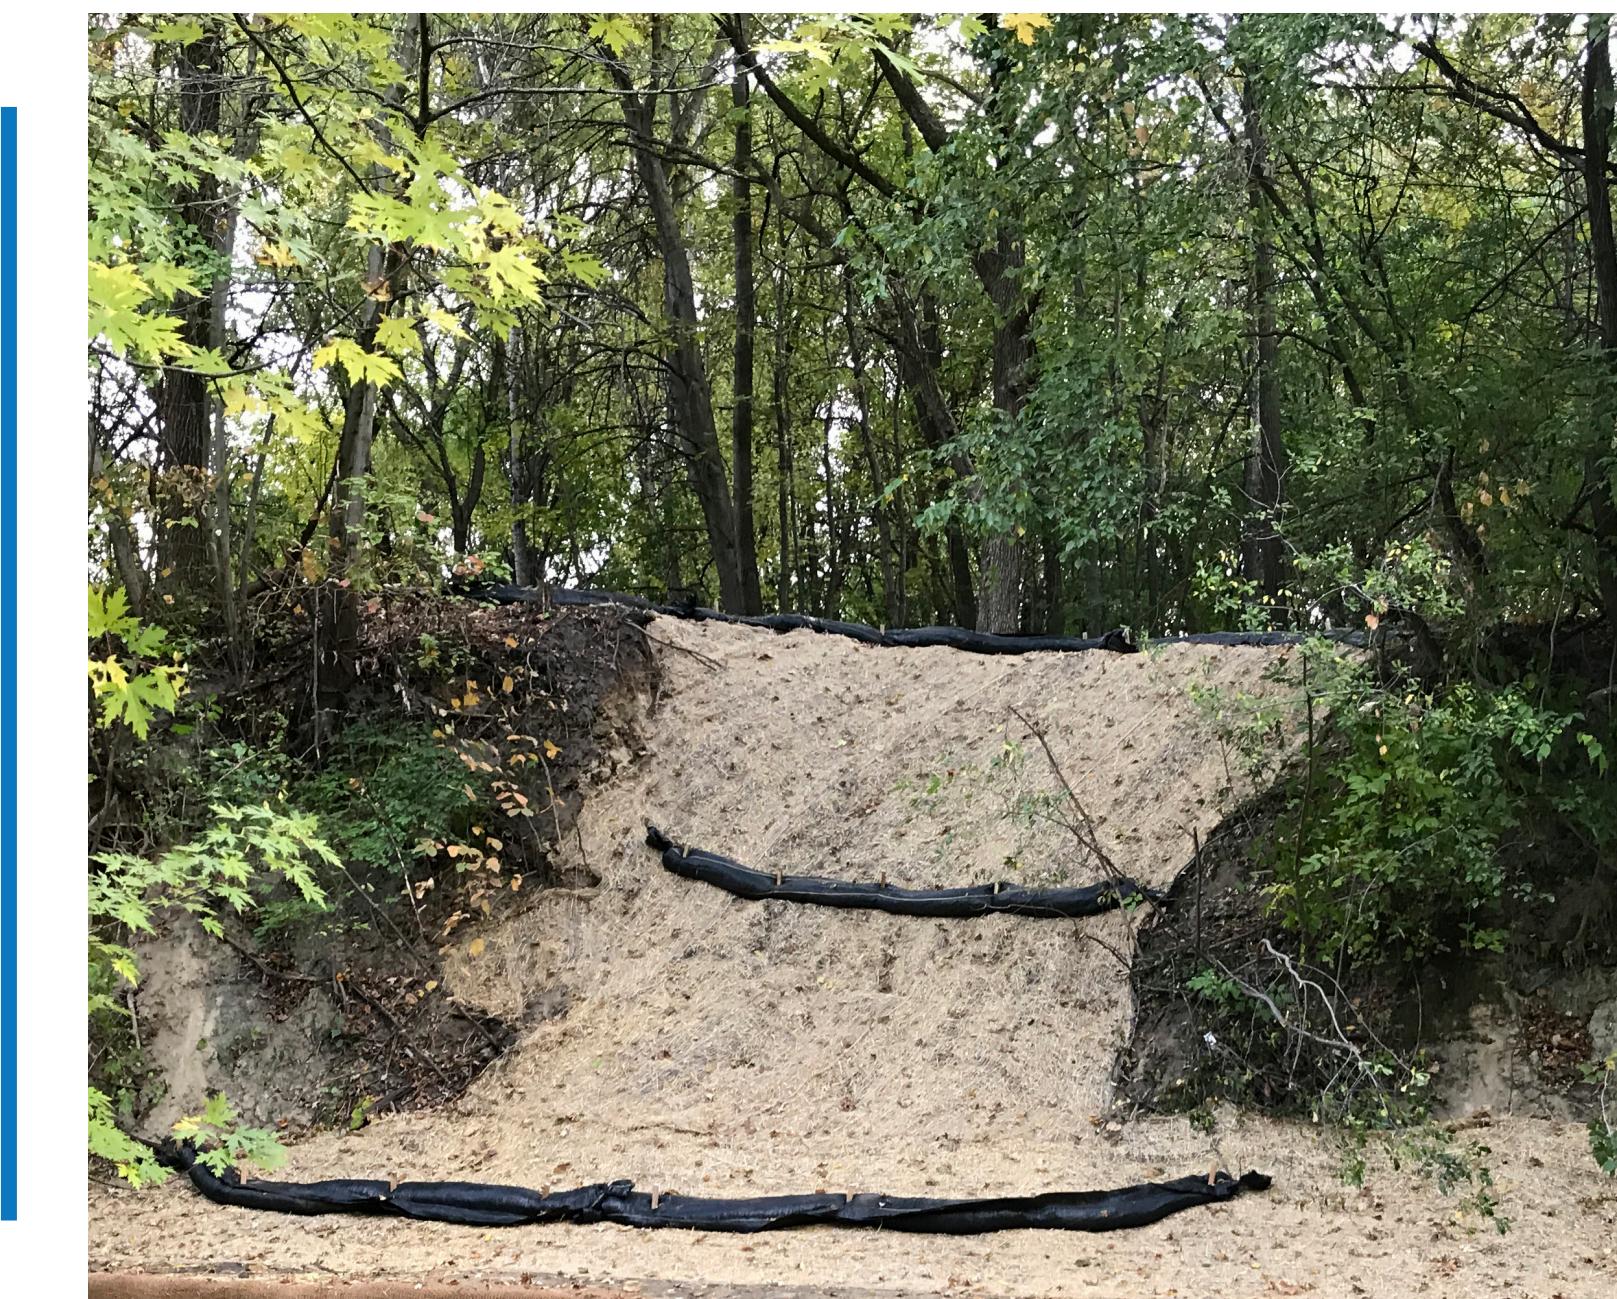
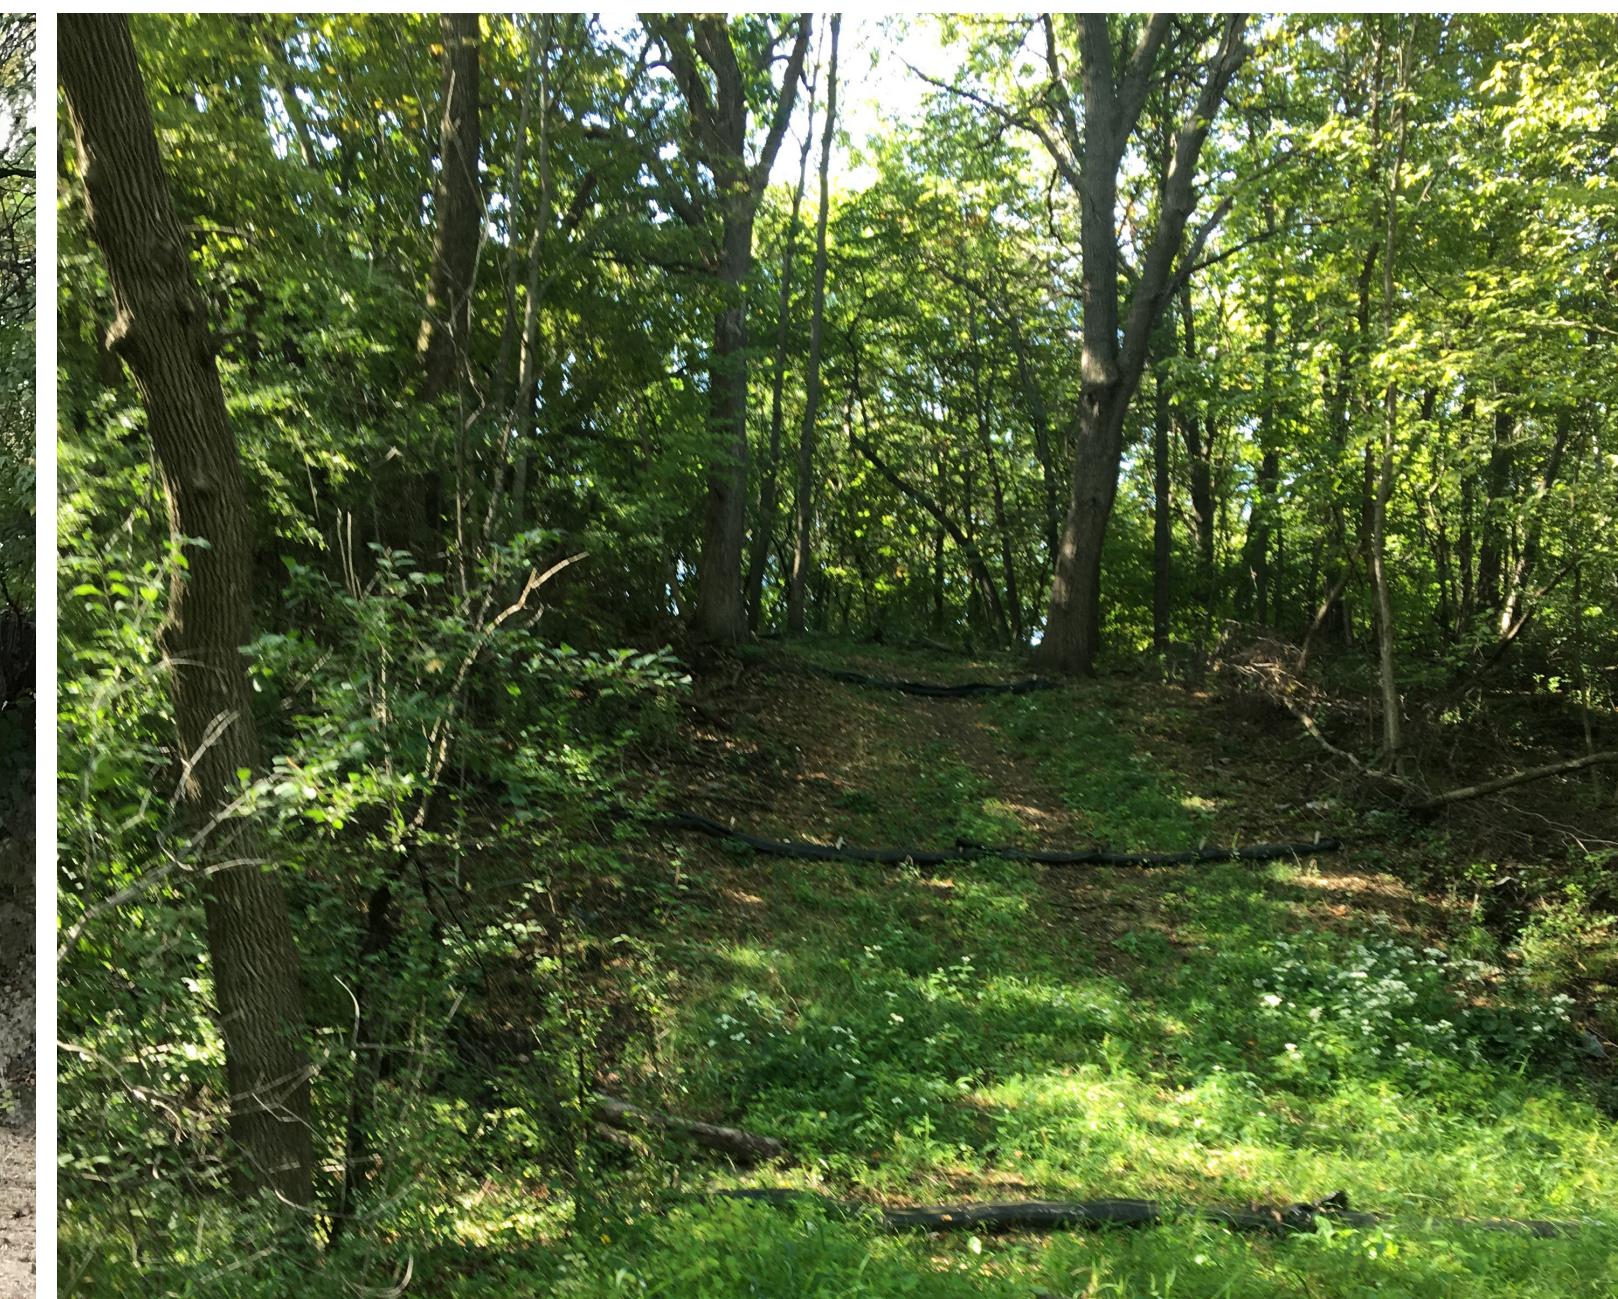
**Construction access refers to a defined path to be used by construction equipment to access or move along stream banks. Homeowners should coordinate with the city to identify landscaping, trees, utilities, or other items to avoid and/or protect, if possible, on their property.**

Construction access can be composed of rock, dirt or mat. Any area used as construction access will be returned to pre-construction conditions or better.

Following construction, access routes will be blanketed and seeded for restoration.
